**West Manchester Township
Invitation to Bid
for the
Rainbow Circle Area Stormwater Repairs Project**

PROJECT: West Manchester Township – Rainbow Circle Area Stormwater Repairs Project

EXISTING CONDITIONS PLAN
 FOR
**RAINBOW CIRCLE
 STORMWATER**
 WEST MANCHESTER TOWNSHIP
 YORK COUNTY
 PENNSYLVANIA

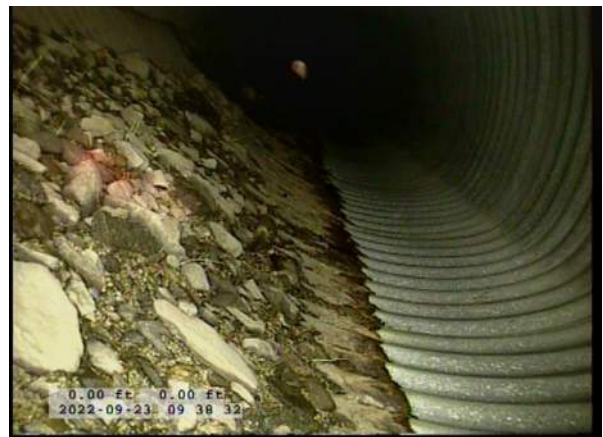
3, 00:00:24, 0.00ft
 Deposits Settled Gravel, 5% of cross sectional area at 6 o'clock, within 8 inch, Start

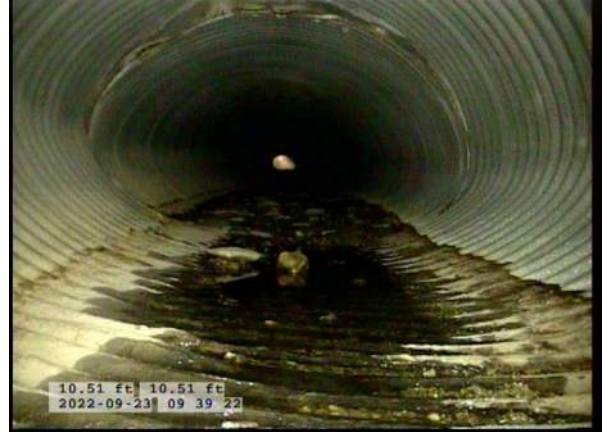
5, 00:00:34, 0.00ft
 Deposits Attached Encrustation, 5% of cross sectional area from 5 o'clock to 7 o'clock, within 8 inch, Start / RUST

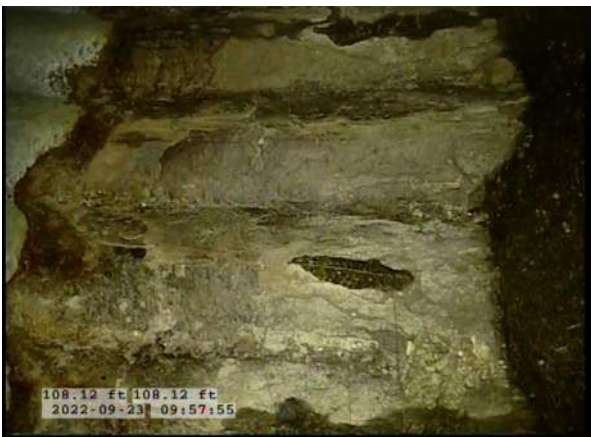
10, 00:05:42, 108.12ft
 Surface Damage Missing Wall from 5 o'clock to 7 o'clock, within 8 inch, Start / BOTTOM OF PIPE STARTING TO RUST AWAY, SMALL HOLES FORMING

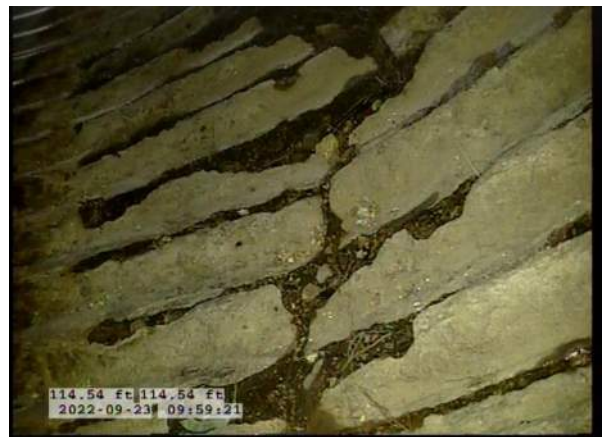
11, 00:05:42, 108.12ft
 Surface Damage Missing Wall from 5 o'clock to 7 o'clock, within 8 inch, Start / BOTTOM OF PIPE STARTING TO RUST AWAY, SMALL HOLES FORMING

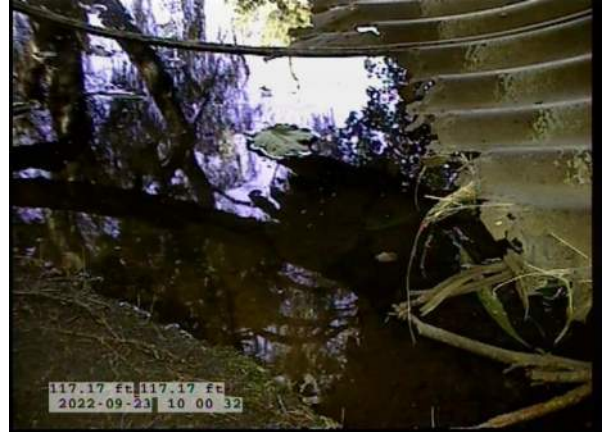
13, 00:06:50, 114.54ft
 Miscellaneous General Photograph from 5 o'clock to 7 o'clock /
 BOTTOM OF PIPE RUSTING AWAY

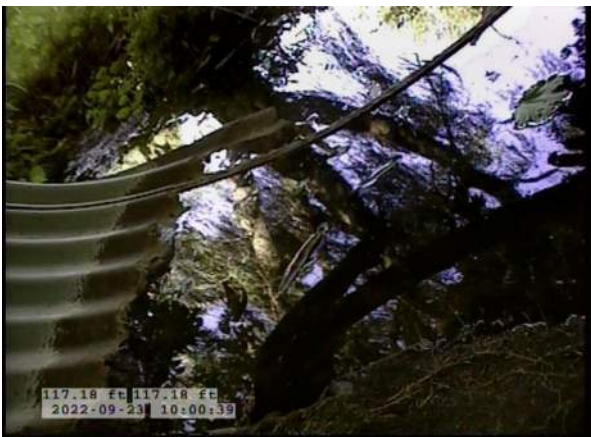
14, 00:07:26, 117.17ft
 Miscellaneous General Photograph from 5 o'clock to 7 o'clock /
 BOTTOM OF PIPE COMPLETELY MISSING AT END OF
 PIPE

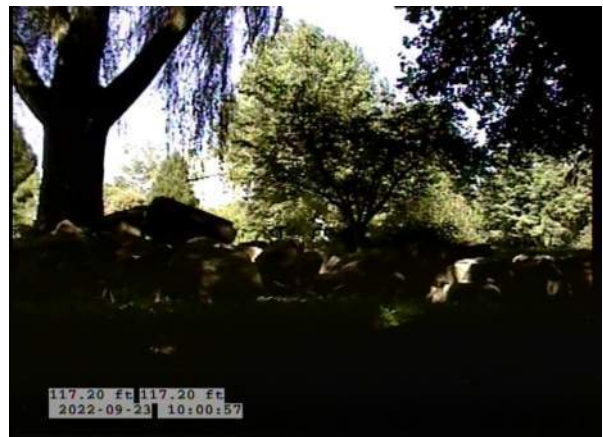
15, 00:07:26, 117.17ft
 Miscellaneous General Photograph from 5 o'clock to 7 o'clock /
 BOTTOM OF PIPE COMPLETELY MISSING AT END OF
 PIPE

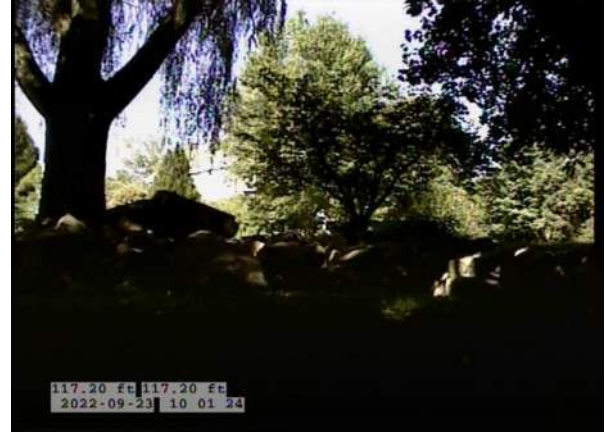
17, 00:07:50, 117.20ft
Surface Damage Missing Wall from 5 o'clock to 7 o'clock,
within 8 inch, Finish / BOTTOM OF PIPE STARTING TO RUST
AWAY, SMALL HOLES FORMING

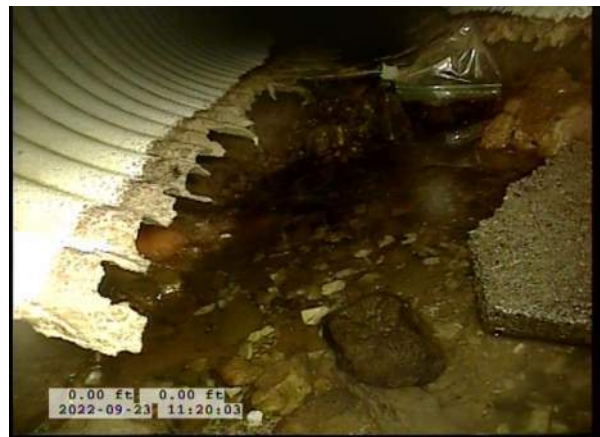
3, 00:00:29, 0.00ft
 Surface Damage Missing Wall from 5 o'clock to 7 o'clock /
 BOTTOM OF PIPE HAS RUSTED AWAY

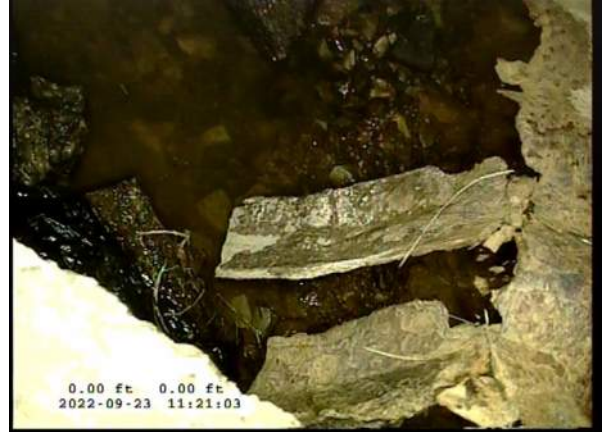
5, 00:01:14, 0.00ft
 Miscellaneous General Photograph from 5 o'clock to 7 o'clock /
 BOTTOM OF PIPE MISSING

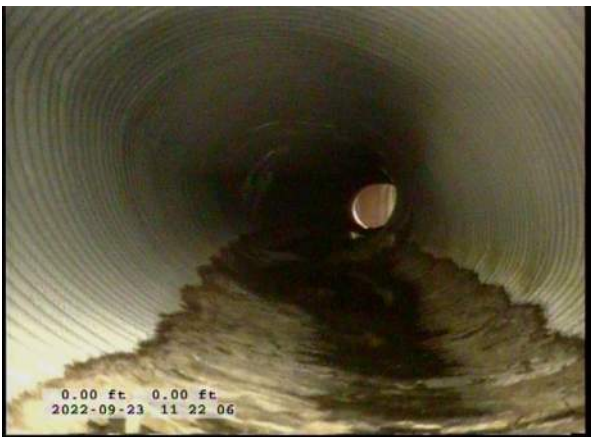
6, 00:01:14, 0.00ft
 Miscellaneous General Photograph from 5 o'clock to 7 o'clock /
 BOTTOM OF PIPE MISSING

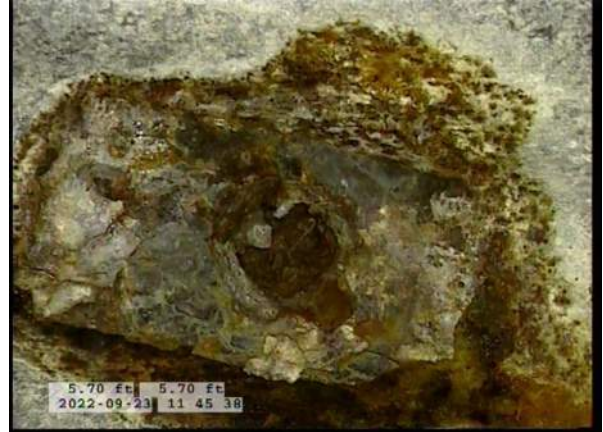
5, 00:00:31, 0.00ft
 Surface Damage Missing Wall from 5 o'clock to 7 o'clock /
 BOTTOM OF PIPE HAS RUSTED AWAY AT START OF LINE

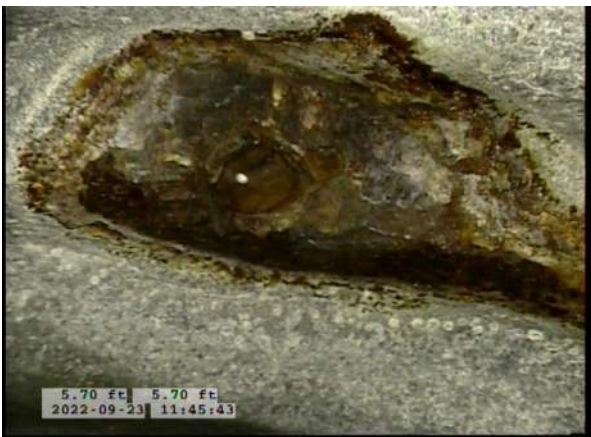
6, 00:01:29, 5.70ft
 Surface Damage Missing Wall from 1 o'clock to 2 o'clock /
 SMALL HOLES

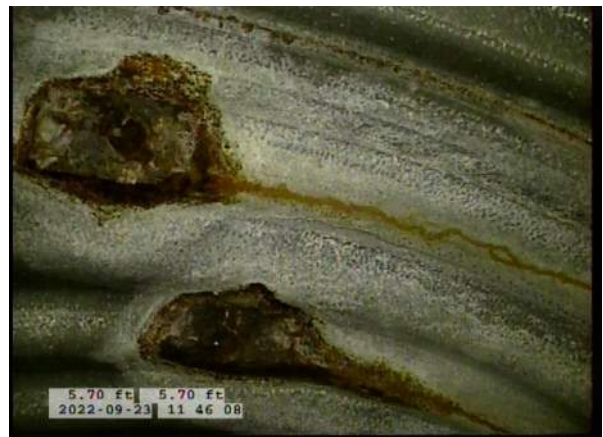
7, 00:01:29, 5.70ft
 Surface Damage Missing Wall from 1 o'clock to 2 o'clock /
 SMALL HOLES

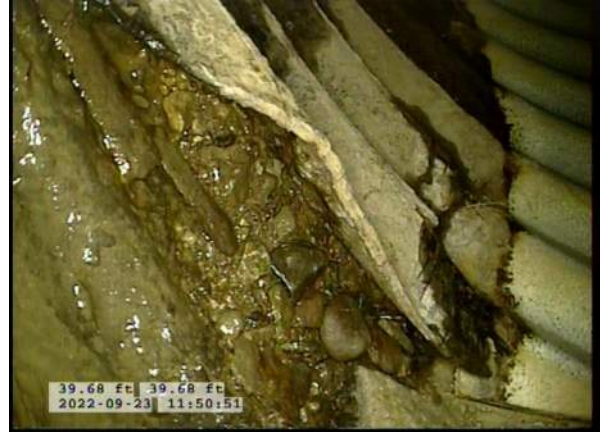
13, 00:05:20, 37.88ft
 Surface Damage Missing Wall from 4 o'clock to 7 o'clock, within 8 inch, Start / BOTTOM OF PIPE HAS BEGUN RUSTING AWAY

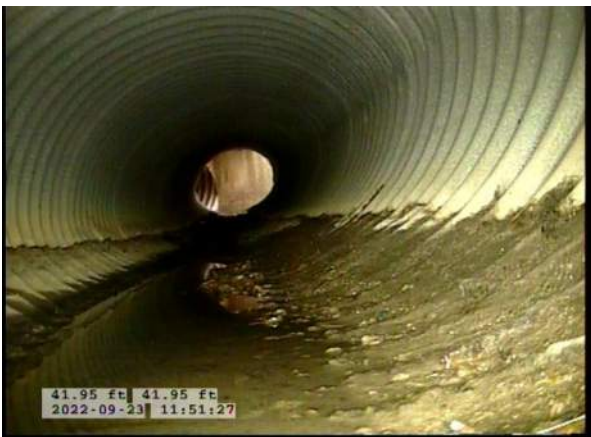
14, 00:05:20, 37.88ft
 Surface Damage Missing Wall from 4 o'clock to 7 o'clock, within 8 inch, Start / BOTTOM OF PIPE HAS BEGUN RUSTING AWAY

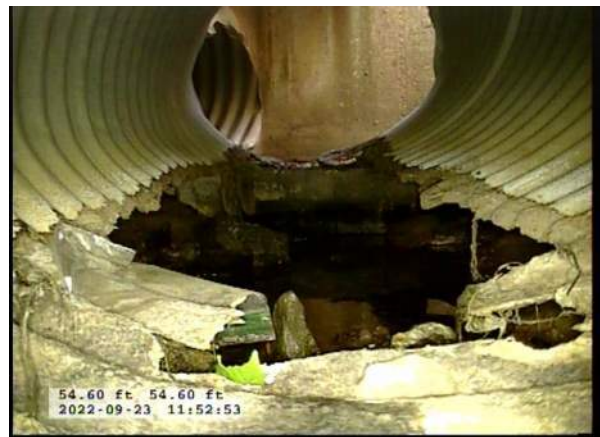
15, 00:06:26, 41.95ft
 Surface Damage Missing Wall from 4 o'clock to 7 o'clock, within 8 inch, Finish / BOTTOM OF PIPE HAS BEGUN RUSTING AWAY

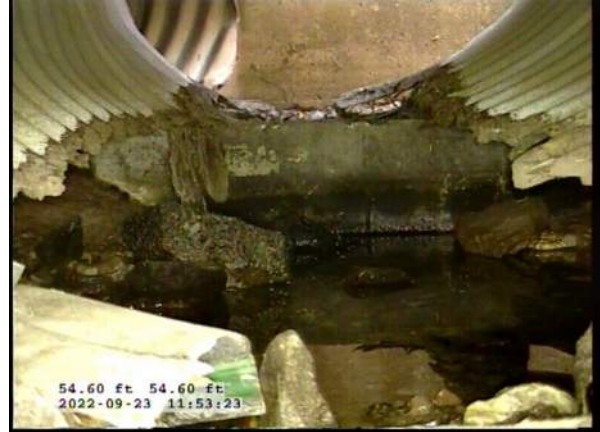
17, 00:07:23, 54.60ft
 Surface Damage Missing Wall from 5 o'clock to 7 o'clock /
 BOTTOM OF PIPE MISSING JUST BEFORE CB7

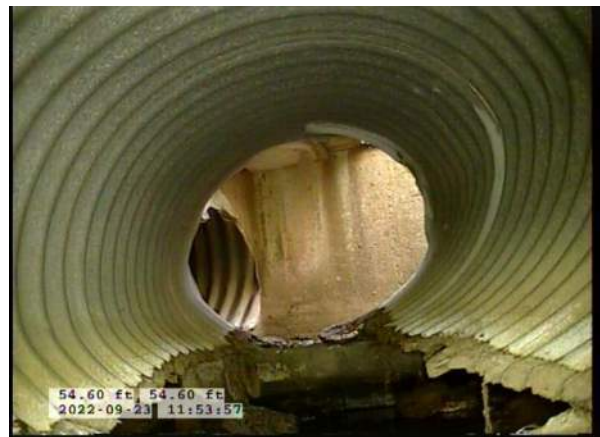
19, 00:07:52, 54.60ft
 Miscellaneous Survey Abandoned / BOTTOM OF PIPE
 MISSING, CRSAWLER CANNOT PROCEED

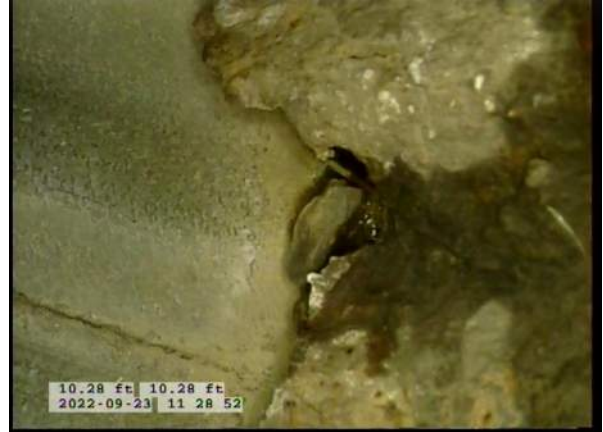
5, 00:01:59, 10.28ft
 Surface Damage Missing Wall from 7 o'clock to 8 o'clock /
 SMALL HOLES FORMING

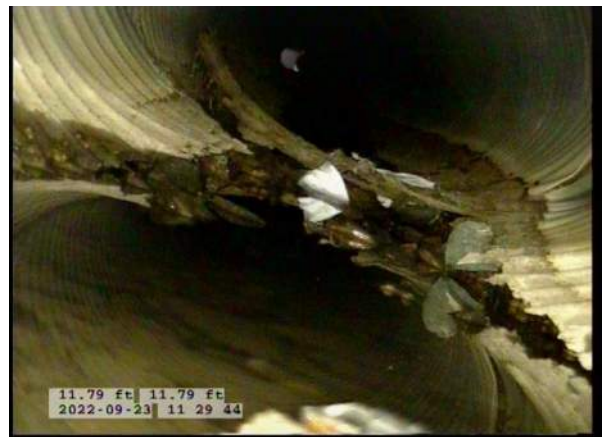
7, 00:02:29, 11.79ft
 Surface Damage Missing Wall from 5 o'clock to 7 o'clock /
 BOTTOM OF PIPE HAS RUSTED AWAY

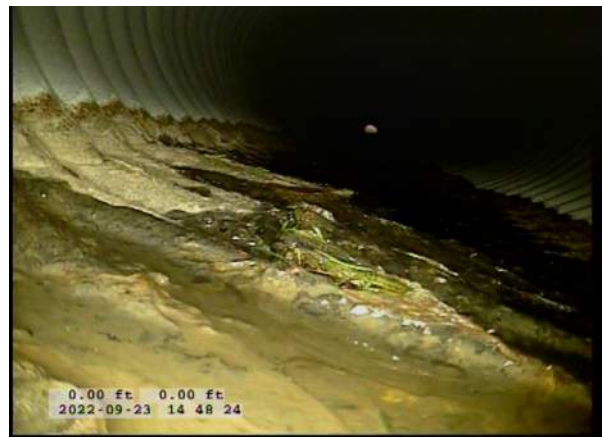
4, 00:00:29, 0.00ft
 Surface Damage Missing Wall from 5 o'clock to 7 o'clock, within 8 inch, Start / BOTTOM OF PIPE HAS BEGUN TO RUST AWAY

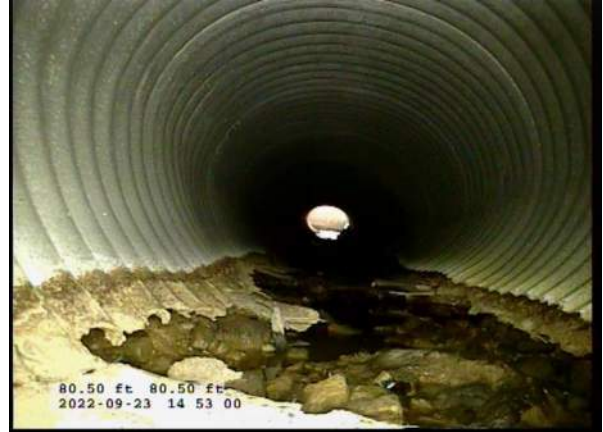
6, 00:04:39, 80.50ft
 Miscellaneous General Photograph from 5 o'clock to 7 o'clock / BOTTOM OF PIPE COMPLETELY MISSING

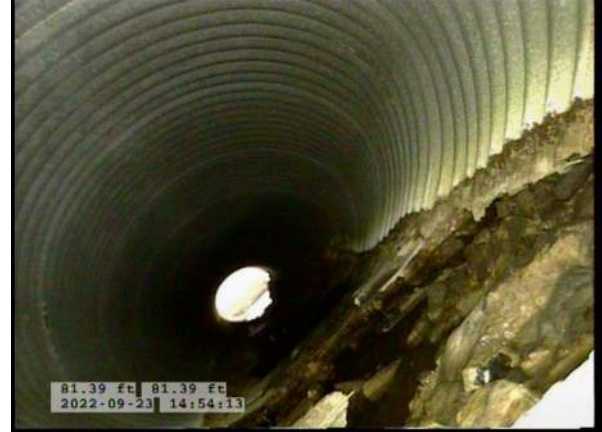
10, 00:05:13, 81.39ft
 Miscellaneous Survey Abandoned / BOTTOM OF PIPE MISSING, OVERLAPPED WITH RUN FROM OPPOSITE DIRECTION

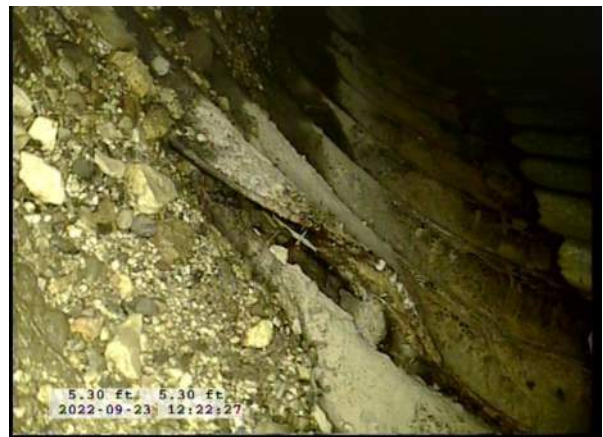
8, 00:02:12, 5.30ft
 Surface Damage Missing Wall from 5 o'clock to 8 o'clock /
 PIPE HAS STARTED TO RUST AWAY

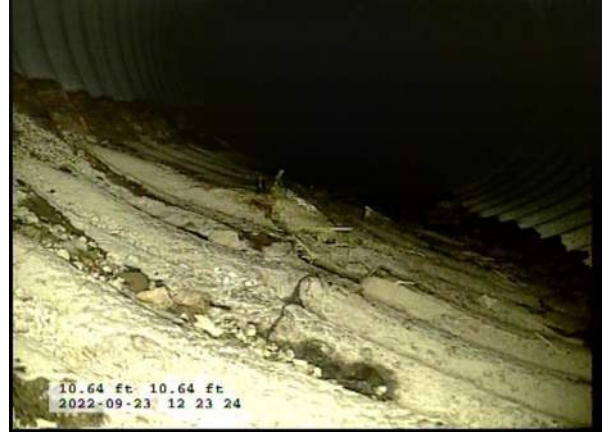
10, 00:02:44, 10.64ft
 Surface Damage Missing Wall from 5 o'clock to 7 o'clock,
 within 8 inch, Start / BOTTOM OF PIPE HAS STARTED TO
 RUST AWAY

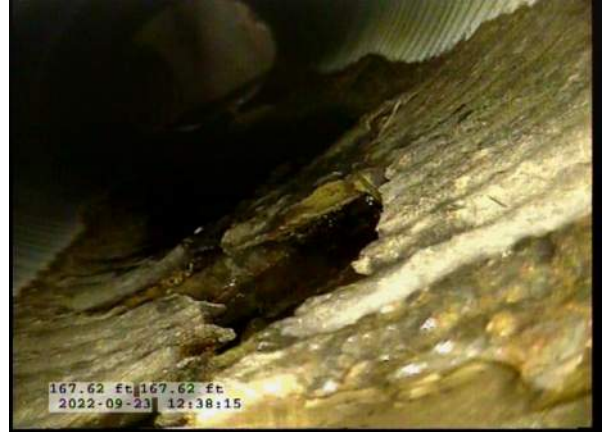
22, 00:15:49, 167.62ft
Miscellaneous Survey Abandoned / BOTTOM OF PIPE
MISSING, CRAWLER CANNOT PROCEED

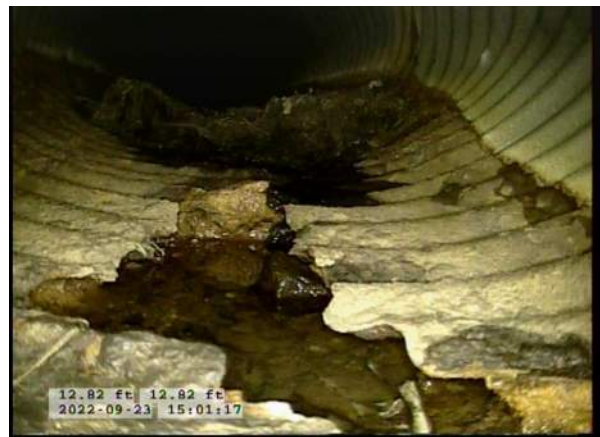
8, 00:01:51, 12.82ft
 Miscellaneous General Observation / BITTOM OF PIPE
 COMPLETELY MISSING

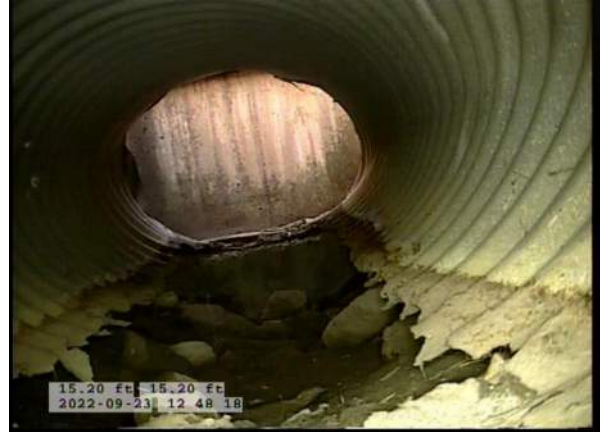
6, 00:01:56, 15.20ft
 Miscellaneous General Photograph from 5 o'clock to 7 o'clock /
 BOIIOM OF PIPE COMPLETELY MISSING JUST BEFORE
 CB4

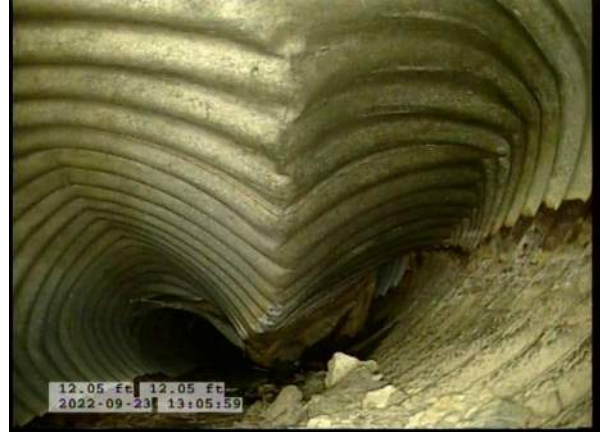
6, 00:01:40, 12.05ft
 Collapse, 80% of cross sectional area

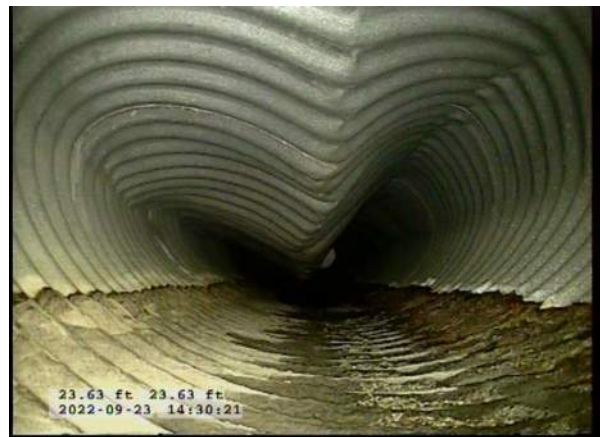
8, 00:01:47, 23.63ft
 Collapse, 80% of cross sectional area

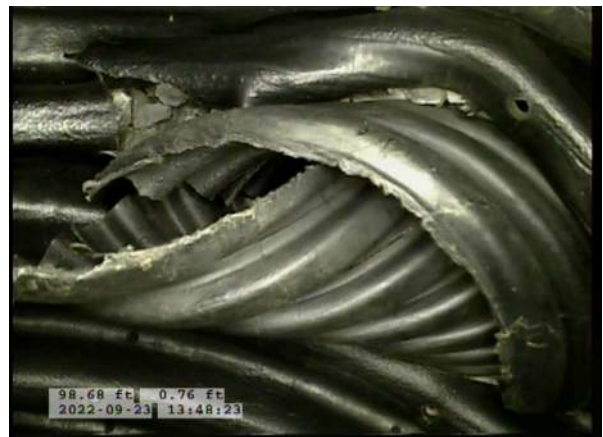
4, 00:05:26, 0.53ft
 Tap Break-In Defective at 1 o'clock, dia/height: 3inch /
 CRUSHED END OF PIPE ON LATERAL

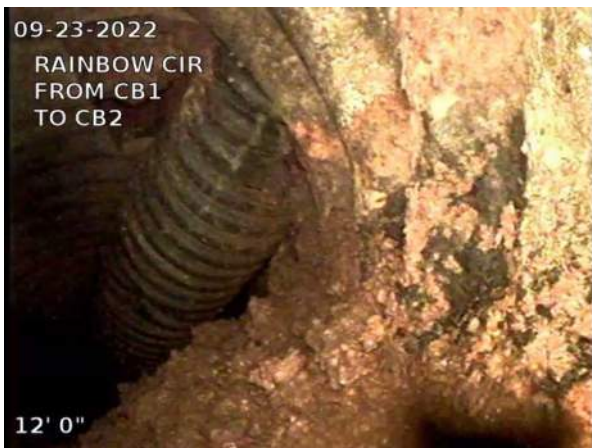
15, 00:01:24, 12.02ft
 Miscellaneous Survey Abandoned / COULD NOT PUSH CAMERA BEYOND POINT WHERE 10 INCH CPP IS IN THE LINE
