**West Manchester Township
Invitation to Bid
for the
Rainbow Circle Area Stormwater Repairs Project**

PROJECT: West Manchester Township – Rainbow Circle Area Stormwater Repairs Project

EXISTING CONDITIONS PLAN
 FOR
**RAINBOW CIRCLE
 STORMWATER**
 WEST MANCHESTER TOWNSHIP
 YORK COUNTY
 PENNSYLVANIA

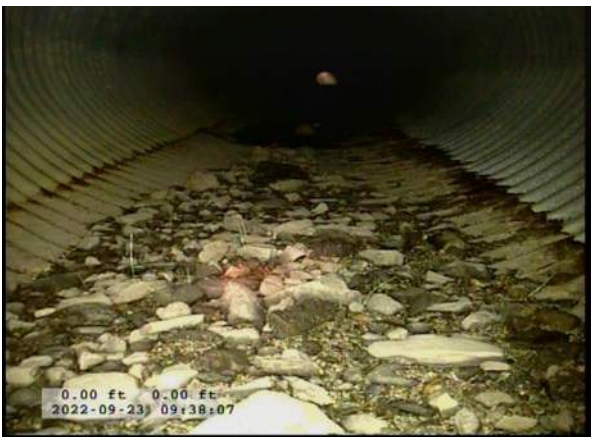
3, 00:00:24, 0.00ft
 Deposits Settled Gravel, 5% of cross sectional area at 6 o'clock, within 8 inch, Start

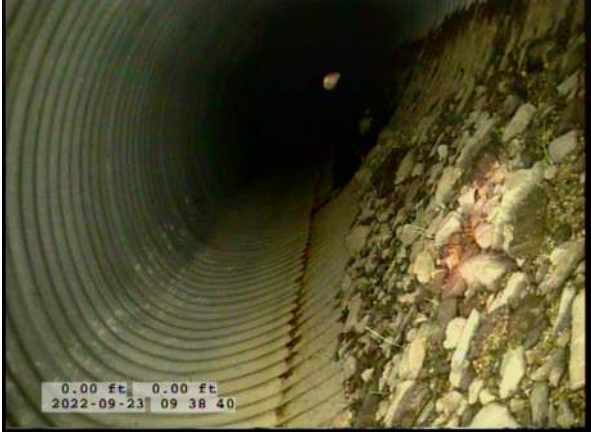
5, 00:00:34, 0.00ft
 Deposits Attached Encrustation, 5% of cross sectional area from 5 o'clock to 7 o'clock, within 8 inch, Start / RUST

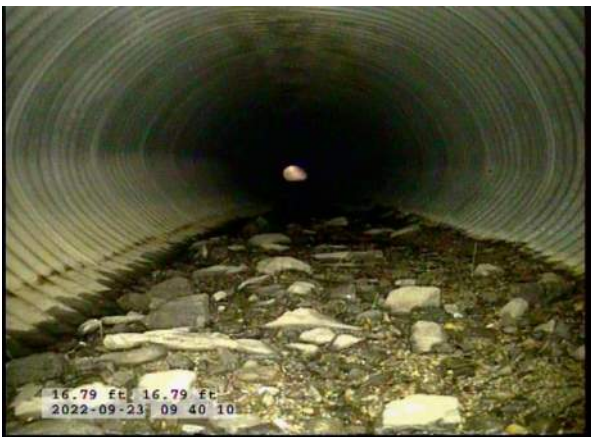
7, 00:02:00, 16.79ft
 Deposits Settled Gravel, 5% of cross sectional area from 5 o'clock to 7 o'clock, within 8 inch, Start

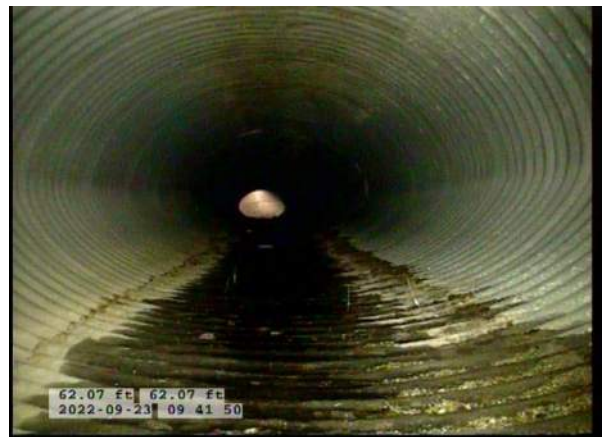
8, 00:03:37, 62.07ft
 Deposits Settled Gravel, 5% of cross sectional area from 5 o'clock to 7 o'clock, within 8 inch, Finish

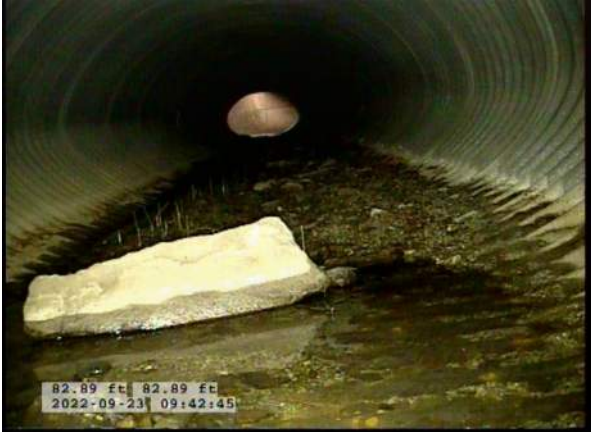
9, 00:04:22, 82.89ft
 Obstruction Rocks, 5% of cross sectional area from 6 o'clock to 7 o'clock

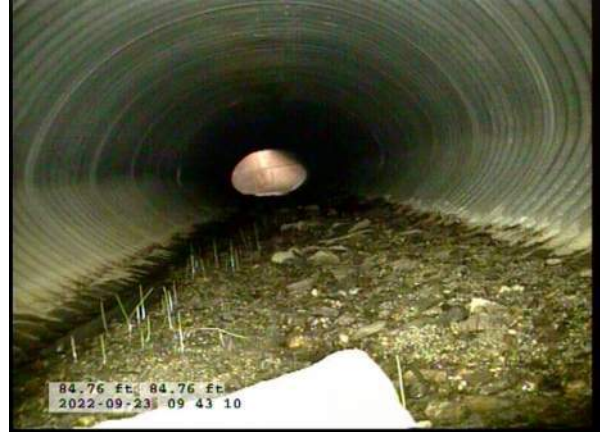
10, 00:04:32, 84.76ft
 Deposits Settled Gravel, 5% of cross sectional area from 5 o'clock to 7 o'clock, within 8 inch, Start

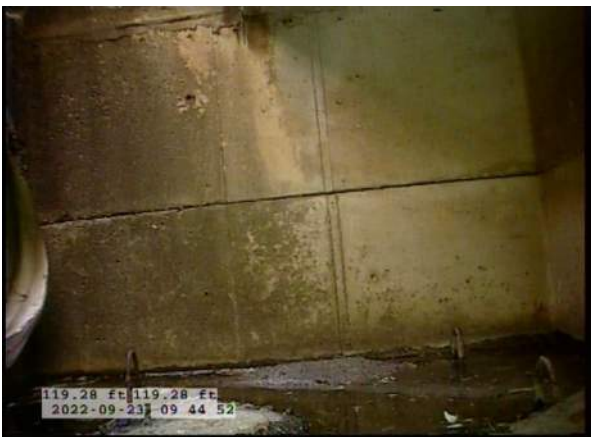
11, 00:06:07, 119.27ft
 Deposits Settled Gravel, 5% of cross sectional area from 5 o'clock to 7 o'clock, within 8 inch, Finish

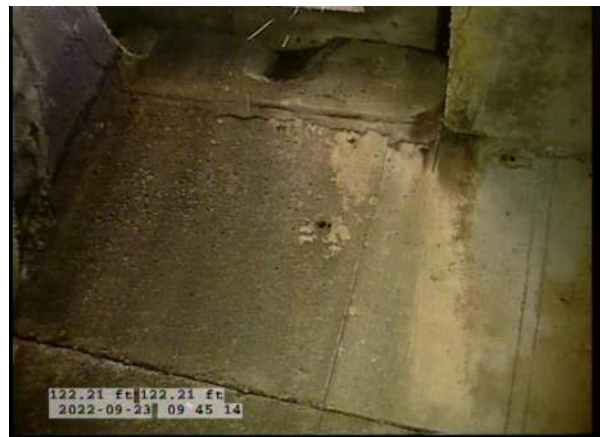
12, 00:06:26, 122.21ft
 Deposits Attached Encrustation, 5% of cross sectional area from 5 o'clock to 7 o'clock, within 8 inch, Finish / RUST

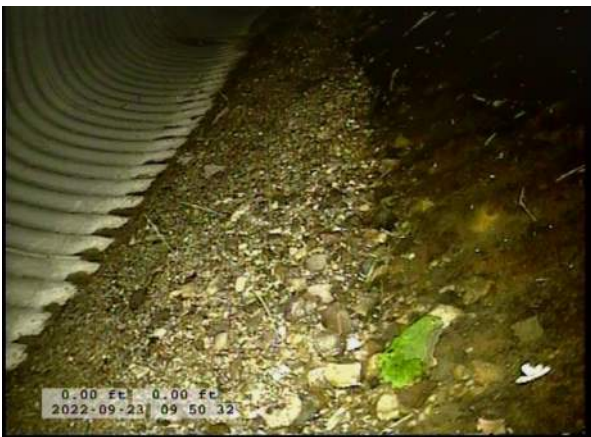
3, 00:00:24, 0.00ft
 Deposits Settled Compacted, 5% of cross sectional area from 6 o'clock to 7 o'clock, within 8 inch, Start

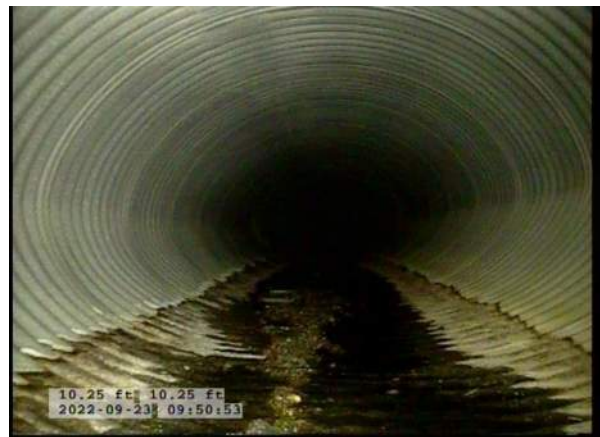
4, 00:00:42, 10.25ft
 Deposits Settled Compacted, 5% of cross sectional area from 6 o'clock to 7 o'clock, within 8 inch, Finish

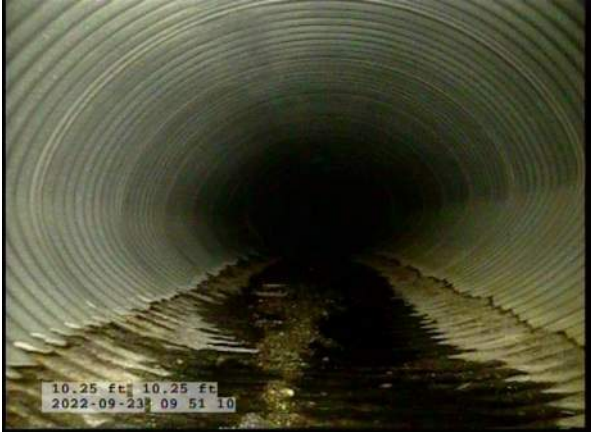
5, 00:00:44, 10.25ft
 Deposits Attached Encrustation, 5% of cross sectional area from 5 o'clock to 7 o'clock, within 8 inch, Start / RUST

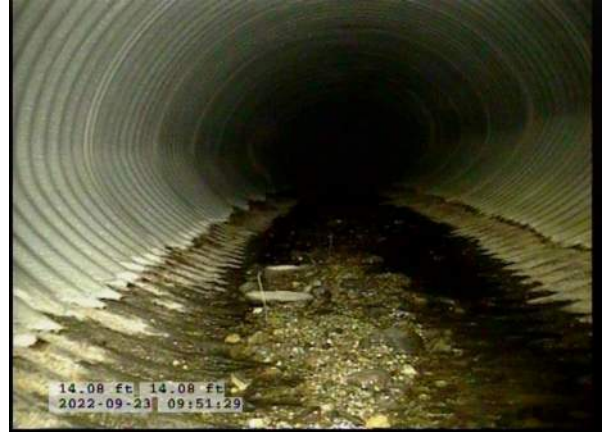
6, 00:00:59, 14.08ft
 Deposits Settled Compacted, 5% of cross sectional area at 6 o'clock, within 8 inch, Start

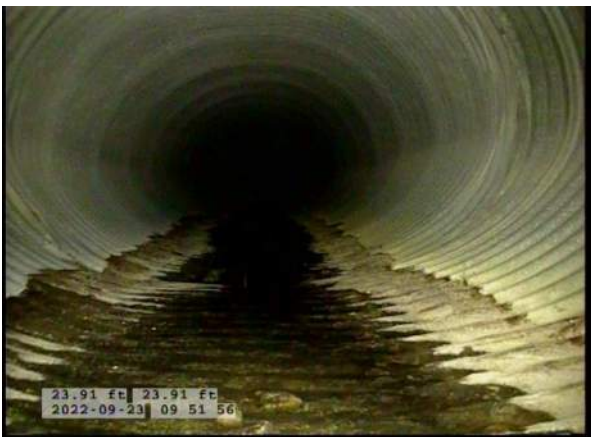
7, 00:01:22, 23.91ft
 Deposits Settled Compacted, 5% of cross sectional area at 6 o'clock, within 8 inch, Finish

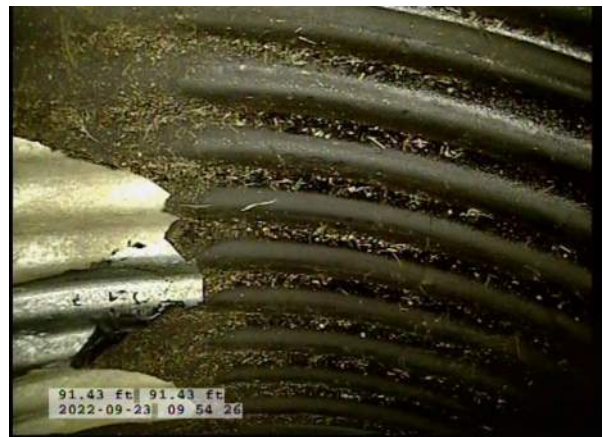
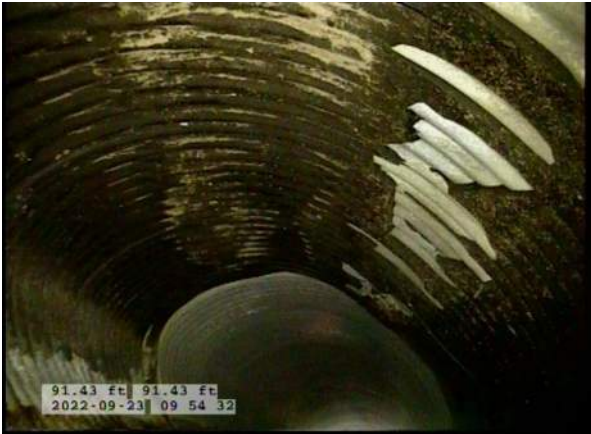
8, 00:03:14, 91.43ft
 Miscellaneous General Observation / BITUMINOUS COATING ON THIS LENGTH OF THE PIPE

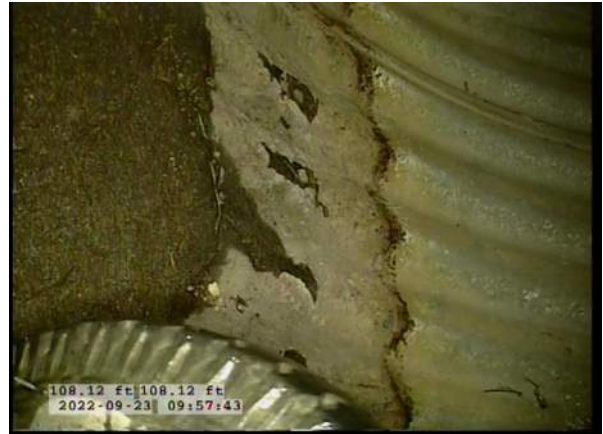
108.1	S04	SMW Surface Damage Missing Wall from 5 o'clock to 7 o'clock, within 8 inch, Start / BOTTOM OF PIPE STARTING TO RUST AWAY, SMALL HOLES FORMING	00:05:42	10, 11

10, 00:05:42, 108.12ft
 Surface Damage Missing Wall from 5 o'clock to 7 o'clock, within 8 inch, Start / BOTTOM OF PIPE STARTING TO RUST AWAY, SMALL HOLES FORMING

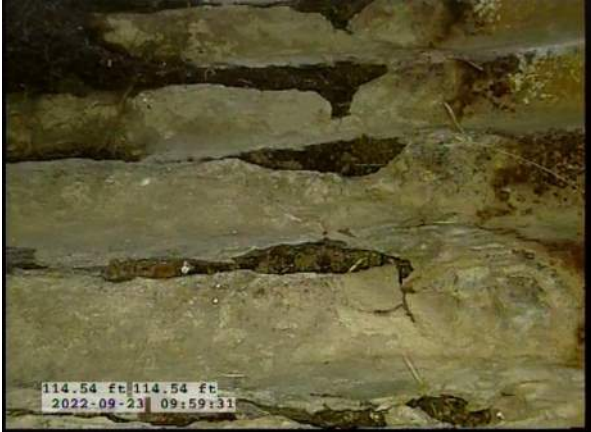
114.5	MGP	Miscellaneous General Photograph from 5 o'clock to 7 o'clock / BOTTOM OF PIPE RUSTING AWAY	00:06:50	12, 13	
	117.2	MGP	Miscellaneous General Photograph from 5 o'clock to 7 o'clock / BOTTOM OF PIPE COMPLETELY MISSING AT END OF PIPE	00:07:26	14, 15

13, 00:06:50, 114.54ft
 Miscellaneous General Photograph from 5 o'clock to 7 o'clock /
 BOTTOM OF PIPE RUSTING AWAY

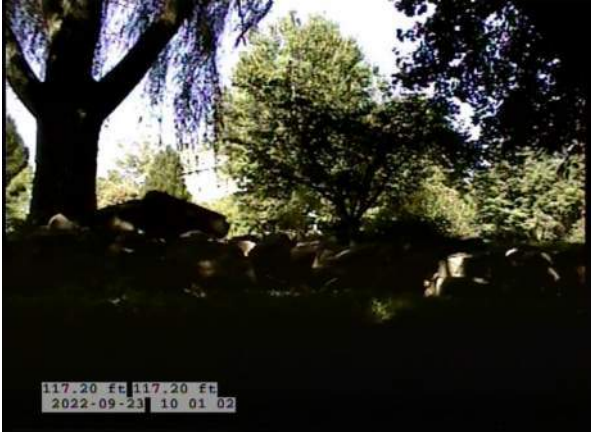
117.2	F02	DAE Deposits Attached Encrustation, 5% of cross sectional area from 5 o'clock to 7 o'clock, within 8 inch, Finish / RUST	00:07:47	16	M2
	117.2	F04	SMW Surface Damage Missing Wall from 5 o'clock to 7 o'clock, within 8 inch, Finish / BOTTOM OF PIPE STARTING TO RUST AWAY, SMALL HOLES FORMING	00:07:50	17	S5

17, 00:07:50, 117.20ft
Surface Damage Missing Wall from 5 o'clock to 7 o'clock,
within 8 inch, Finish / BOTTOM OF PIPE STARTING TO RUST
AWAY, SMALL HOLES FORMING

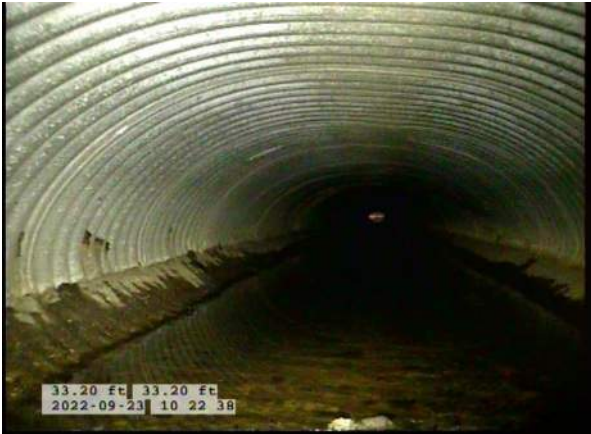
5, 00:02:12, 33.20ft
 Deposits Settled Gravel, 5% of cross sectional area from 6 o'clock to 7 o'clock, within 8 inch, Finish

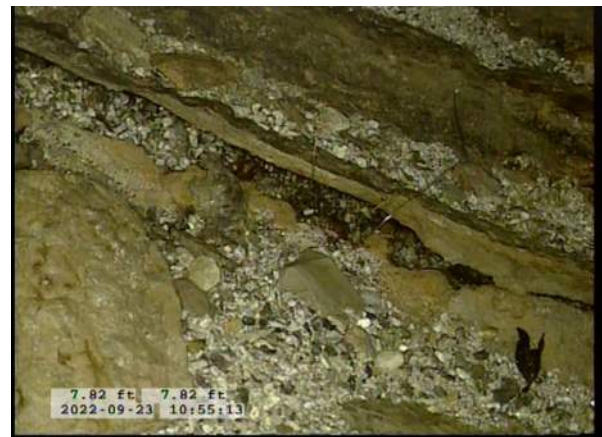
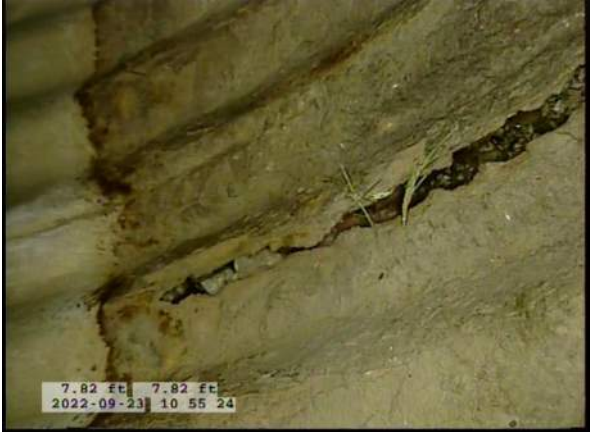
4, 00:01:06, 7.82ft
 Surface Damage Missing Wall from 5 o'clock to 7 o'clock / BOTTOM OF PIPE STARTING TO RUST AWAY

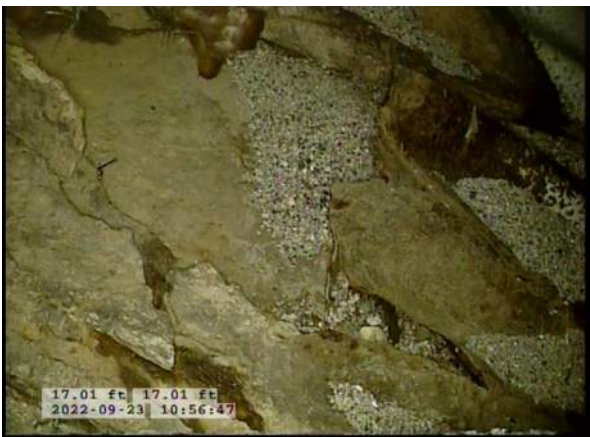
7, 00:01:53, 16.23ft
 Surface Damage Missing Wall from 5 o'clock to 7 o'clock /
 BOTTOM OF PIPE RUSTING AWAY

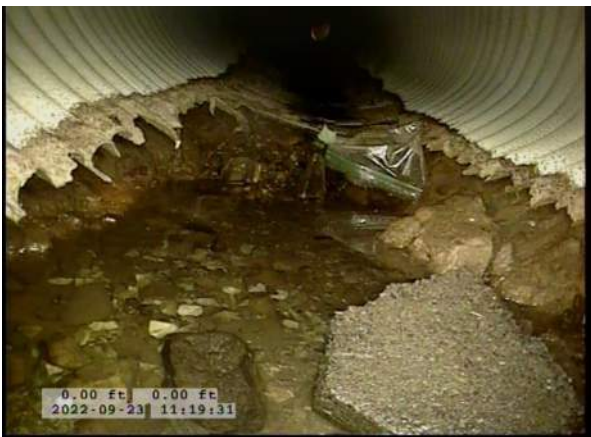
3, 00:00:29, 0.00ft
 Surface Damage Missing Wall from 5 o'clock to 7 o'clock /
 BOTTOM OF PIPE HAS RUSTED AWAY

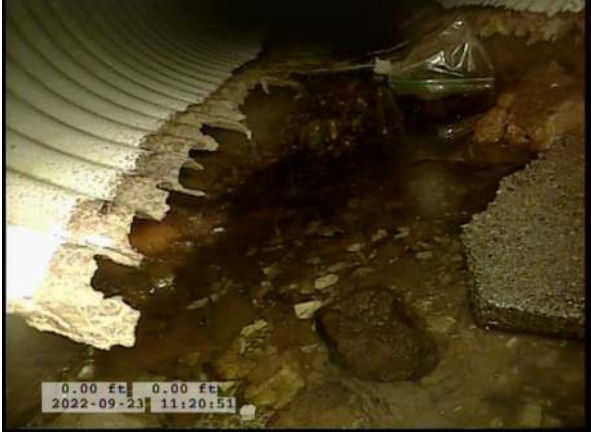
5, 00:01:14, 0.00ft
 Miscellaneous General Photograph from 5 o'clock to 7 o'clock /
 BOTTOM OF PIPE MISSING

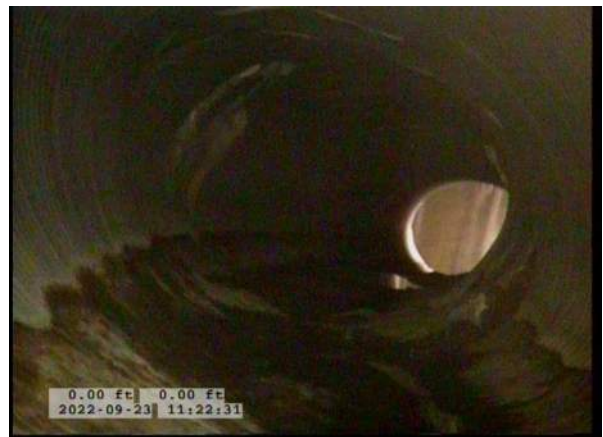
8, 00:01:43, 0.00ft
 Miscellaneous General Photograph from 12 o'clock to 12
 o'clock / ZOOMING CAMERA DOWNPIPE, CB8 VISIBLE

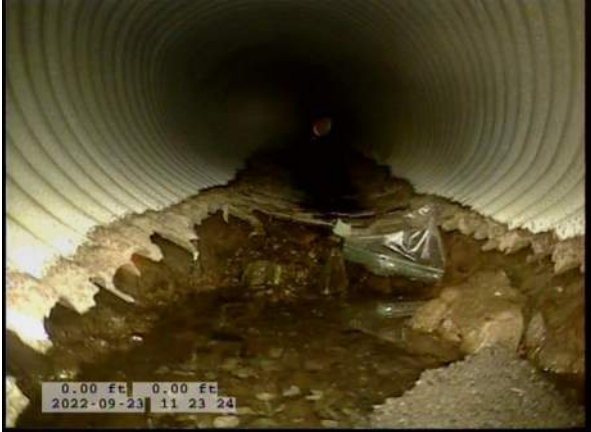
9, 00:02:30, 0.00ft
Miscellaneous Survey Abandoned / BOTTOM OF PIPE
MISSING, CRAWLER CANNOT ENTER LINE

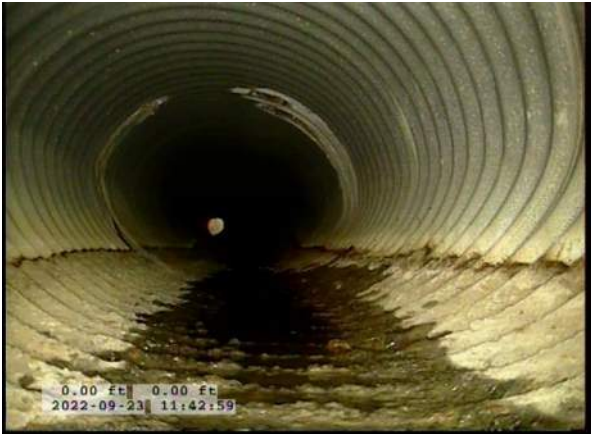
1, 00:00:10, 0.00ft
 Catch Basin / CB8

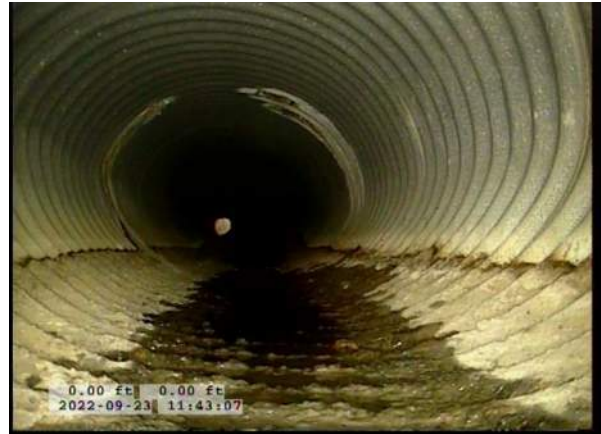
2, 00:00:13, 0.00ft
 Water Level, 0% of the vertical dimension

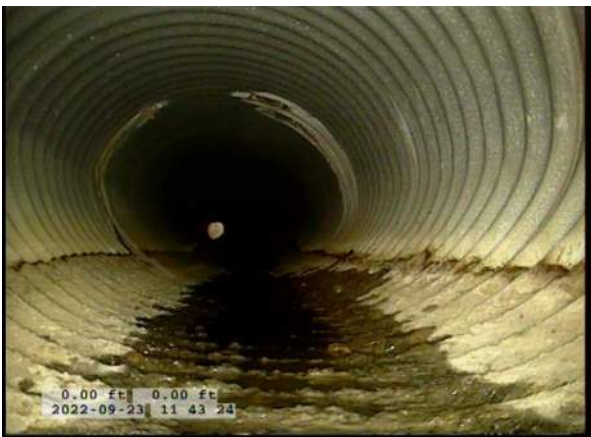
3, 00:00:17, 0.00ft
 Deposits Attached Encrustation, 5% of cross sectional area from 5 o'clock to 7 o'clock, within 8 inch, Start / RUST

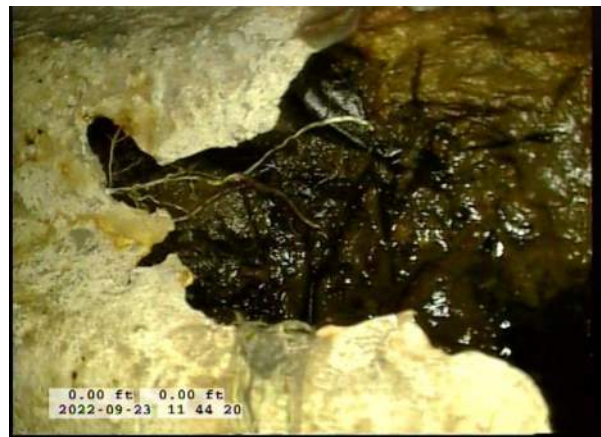
0.0 S01	DAE	Deposits Attached Encrustation, 5% of cross sectional area from 5 o'clock to 7 o'clock, within 8 inch, Start / RUST	00:00:17	3			
	0.0	SMW	Surface Damage Missing Wall from 5 o'clock to 7 o'clock / BOTTOM OF PIPE HAS RUSTED AWAY AT START OF LINE	00:00:31	4, 5	S5

4, 00:00:31, 0.00ft
 Surface Damage Missing Wall from 5 o'clock to 7 o'clock / BOTTOM OF PIPE HAS RUSTED AWAY AT START OF LINE

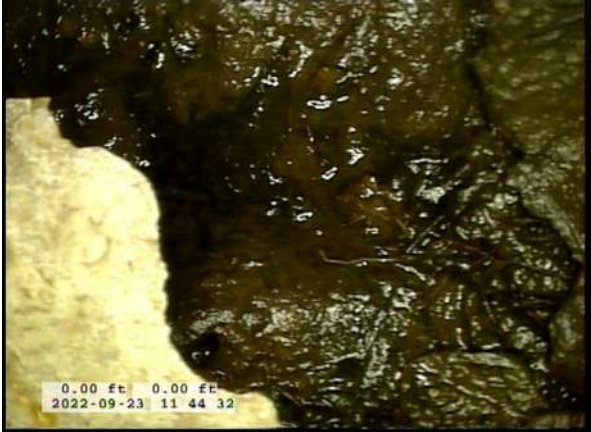
5, 00:00:31, 0.00ft
 Surface Damage Missing Wall from 5 o'clock to 7 o'clock /
 BOTTOM OF PIPE HAS RUSTED AWAY AT START OF LINE

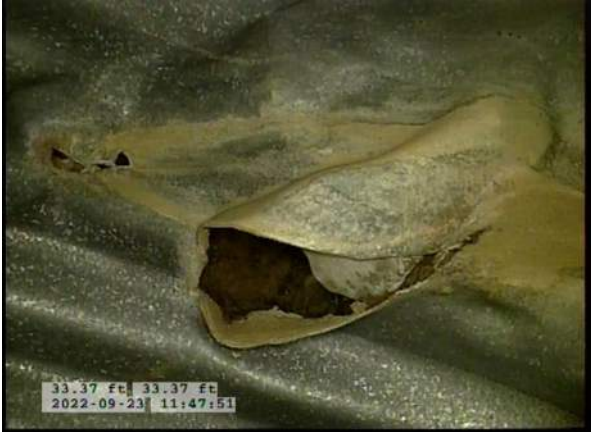
9, 00:03:28, 33.37ft
 Hole Soil Visible from 2 o'clock to 3 o'clock

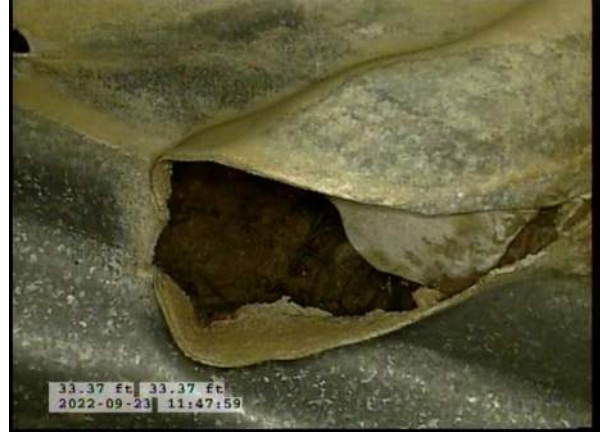
10, 00:03:28, 33.37ft
 Hole Soil Visible from 2 o'clock to 3 o'clock

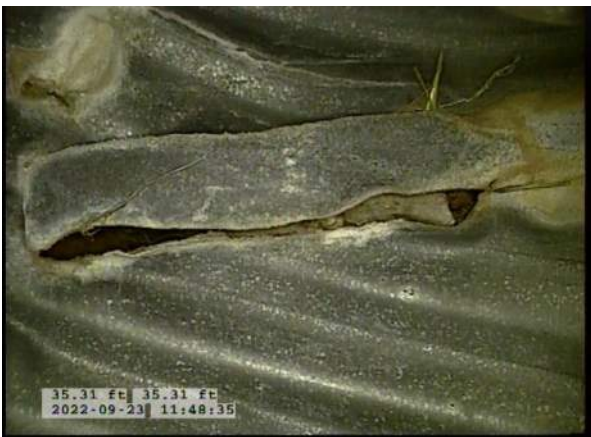
11, 00:04:04, 35.31ft
 Hole Soil Visible from 2 o'clock to 3 o'clock

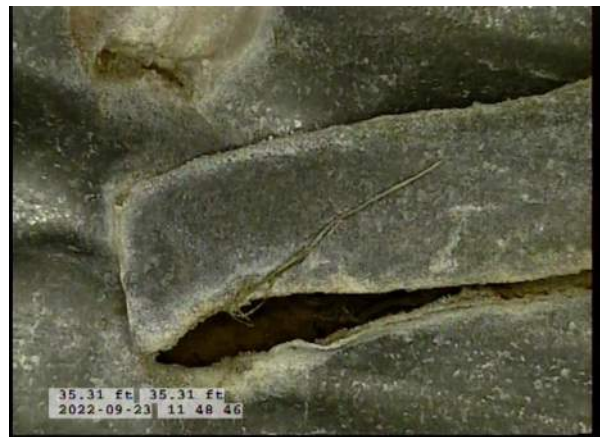
12, 00:04:04, 35.31ft
 Hole Soil Visible from 2 o'clock to 3 o'clock

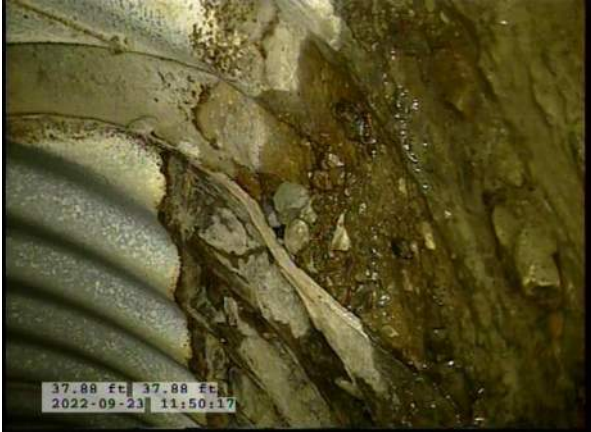
37.9 S02	SMW	Surface Damage Missing Wall from 4 o'clock to 7 o'clock, within 8 inch, Start / BOTTOM OF PIPE HAS BEGUN RUSTING AWAY	00:05:20	13, 14			
	42.0 F02	SMW	Surface Damage Missing Wall from 4 o'clock to 7 o'clock, within 8 inch, Finish / BOTTOM OF PIPE HAS BEGUN RUSTING AWAY	00:06:26	15	S5

13, 00:05:20, 37.88ft
 Surface Damage Missing Wall from 4 o'clock to 7 o'clock, within 8 inch, Start / BOTTOM OF PIPE HAS BEGUN RUSTING AWAY

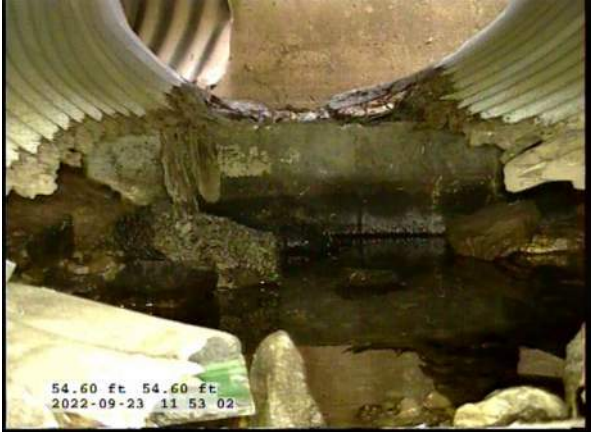
54.6	SMW	Surface Damage Missing Wall from 5 o'clock to 7 o'clock / BOTTOM OF PIPE MISSING JUST BEFORE CB7	00:07:23	16, 17	S5		
	54.6 F01	DAE	Deposits Attached Encrustation, 5% of cross sectional area from 5 o'clock to 7 o'clock, within 8 inch, Finish / RUST	00:07:49	18	M2

17, 00:07:23, 54.60ft
 Surface Damage Missing Wall from 5 o'clock to 7 o'clock /
 BOTTOM OF PIPE MISSING JUST BEFORE CB7

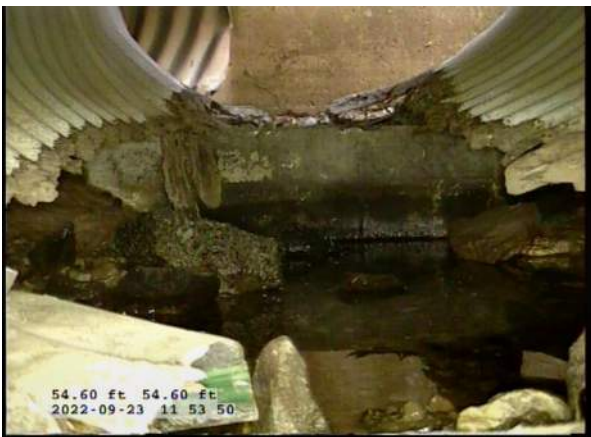
54.6	MSA	Miscellaneous Survey Abandoned / BOTTOM OF PIPE MISSING, CRSAWLER CANNOT PROCEED	00:07:52	19, 20			
QSR	QMR	QOR	SPR	MPR	OPR	SPRI	MPRI	OPRI
5600	2A11	562A	30.0	23.0	53.0	5.0	1.9	2.9

19, 00:07:52, 54.60ft
 Miscellaneous Survey Abandoned / BOTTOM OF PIPE
 MISSING, CRSAWLER CANNOT PROCEED

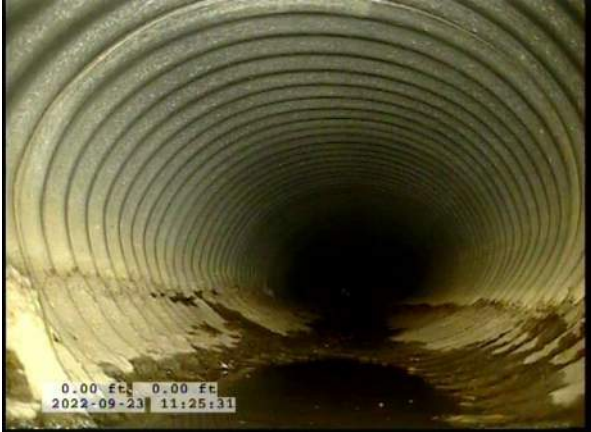
1, 00:00:11, 0.00ft
 Catch Basin / CB7

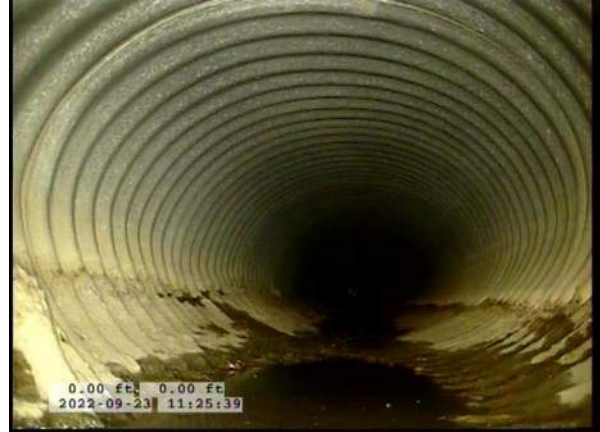
2, 00:00:13, 0.00ft
 Water Level, 0% of the vertical dimension

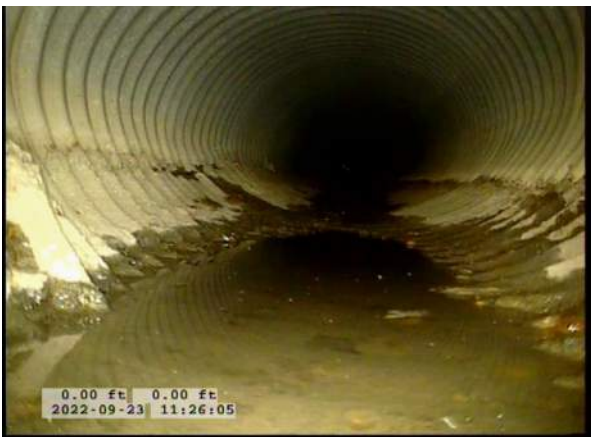
3, 00:00:24, 0.00ft
 Deposits Attached Encrustation, 5% of cross sectional area from 4 o'clock to 8 o'clock, within 8 inch, Start / RUST

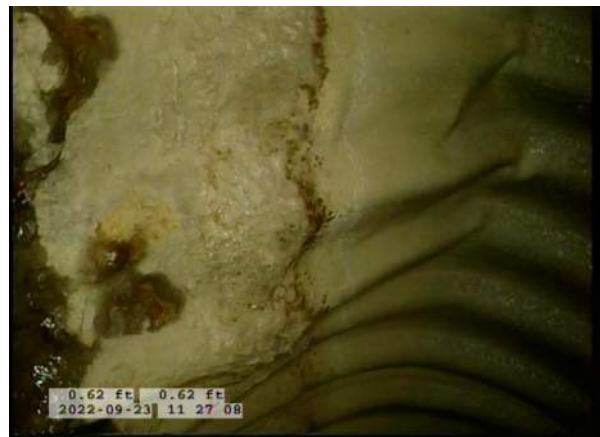
0.0	S01 DAE	Deposits Attached Encrustation, 5% of cross sectional area from 4 o'clock to 8 o'clock, within 8 inch, Start / RUST	00:00:24	3	
	0.6	DFBR	Deformed Flexible Bulging Round, change to: 5% from 7 o'clock to 9 o'clock	00:00:42	4	S3

4, 00:00:42, 0.62ft
 Deformed Flexible Bulging Round, change to: 5% from 7 o'clock to 9 o'clock

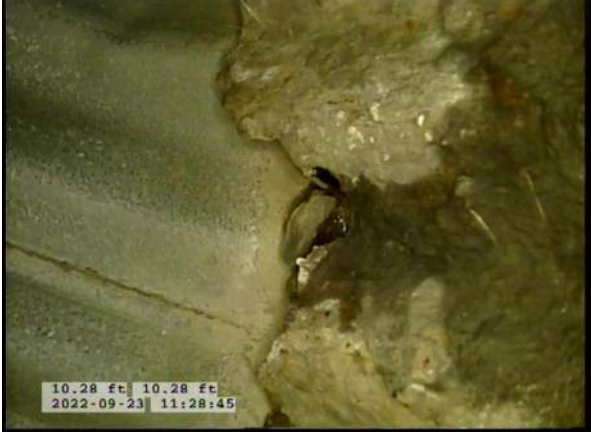
10.3	SMW	Surface Damage Missing Wall from 7 o'clock to 8 o'clock / SMALL HOLES FORMING	00:01:59	5, 6	S5
	11.8	SMW	Surface Damage Missing Wall from 5 o'clock to 7 o'clock / BOTTOM OF PIPE HAS RUSTED AWAY	00:02:29	7, 8	S5

5, 00:01:59, 10.28ft
 Surface Damage Missing Wall from 7 o'clock to 8 o'clock /
 SMALL HOLES FORMING

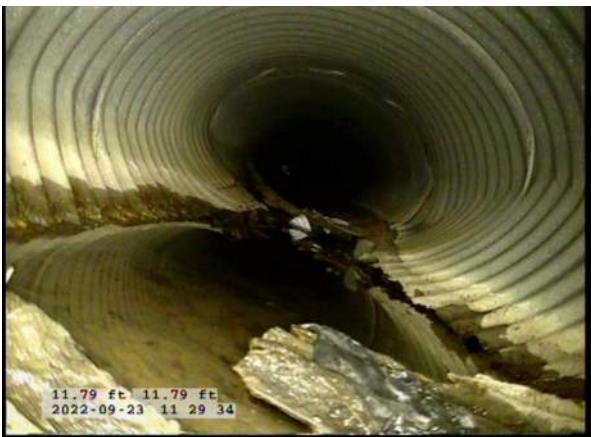
7, 00:02:29, 11.79ft
 Surface Damage Missing Wall from 5 o'clock to 7 o'clock /
 BOTTOM OF PIPE HAS RUSTED AWAY

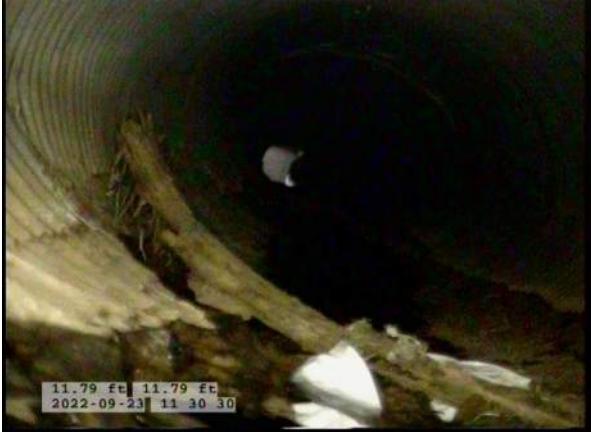
9, 00:02:57, 11.79ft
 Miscellaneous General Photograph from 12 o'clock to 12 o'clock / ZOOMING CAMERA DOWNPIPE, CB6 VISIBLE

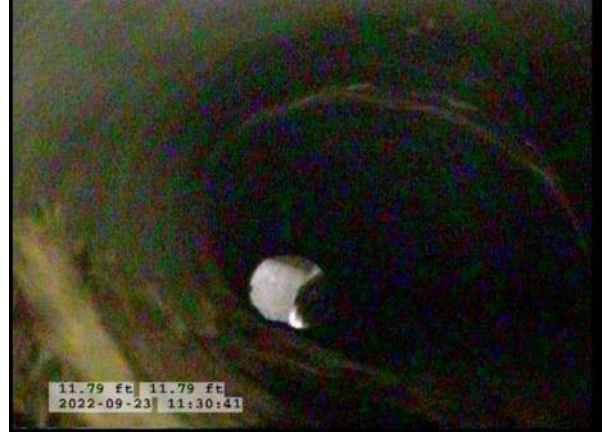
10, 00:02:57, 11.79ft
 Miscellaneous General Photograph from 12 o'clock to 12 o'clock / ZOOMING CAMERA DOWNPIPE, CB6 VISIBLE

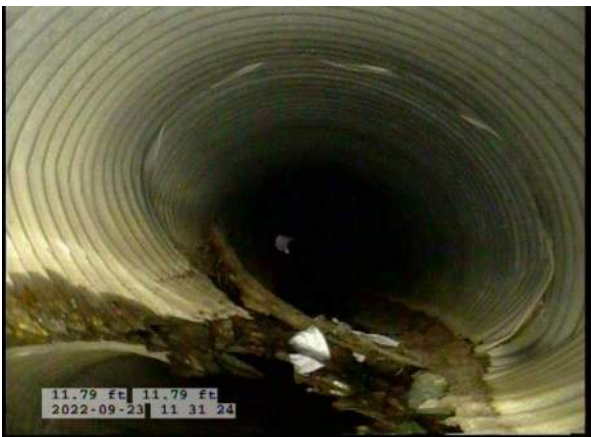
11, 00:03:20, 11.79ft
 Deposits Attached Encrustation, 5% of cross sectional area from 4 o'clock to 8 o'clock, within 8 inch, Finish / RUST

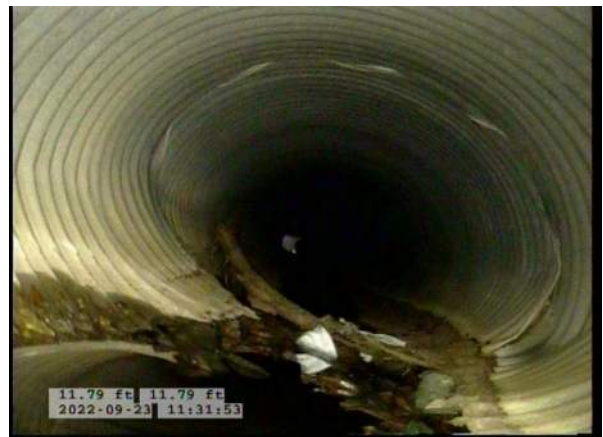
11.8	MSA	Miscellaneous Survey Abandoned / BOTTOM OF PIPE MISSING, CRAWLER CANNOT PROCEED	00:03:23	12, 13	
	81.4		End of pipe

12, 00:03:23, 11.79ft
 Miscellaneous Survey Abandoned / BOTTOM OF PIPE MISSING, CRAWLER CANNOT PROCEED

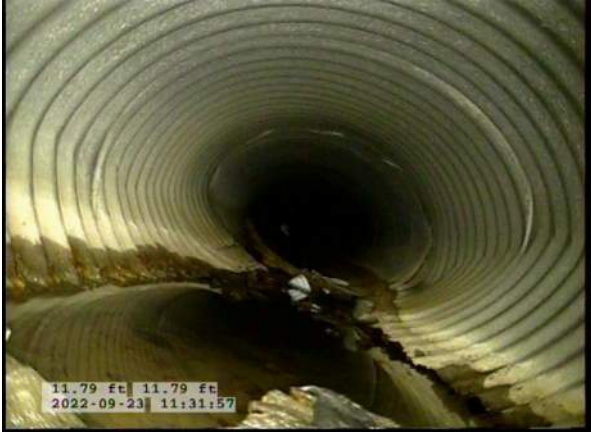
13, 00:03:23, 11.79ft
Miscellaneous Survey Abandoned / BOTTOM OF PIPE
MISSING, CRAWLER CANNOT PROCEED

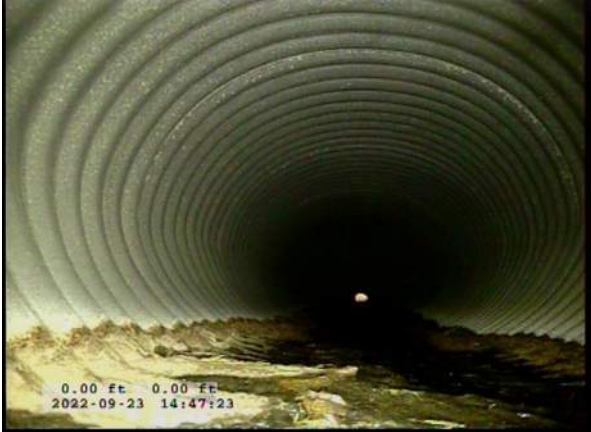
1, 00:00:11, 0.00ft
 Catch Basin / CB6

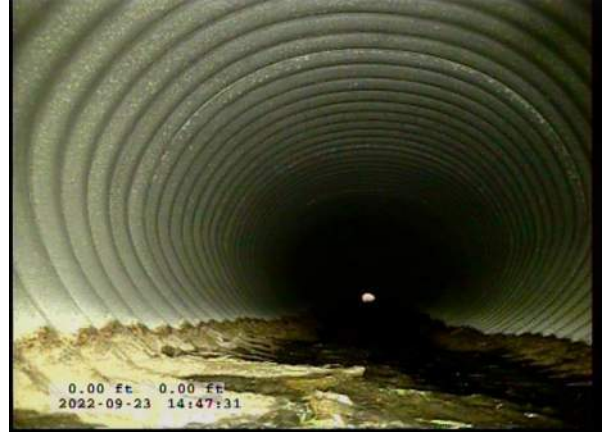
2, 00:00:14, 0.00ft
 Water Level, 0% of the vertical dimension

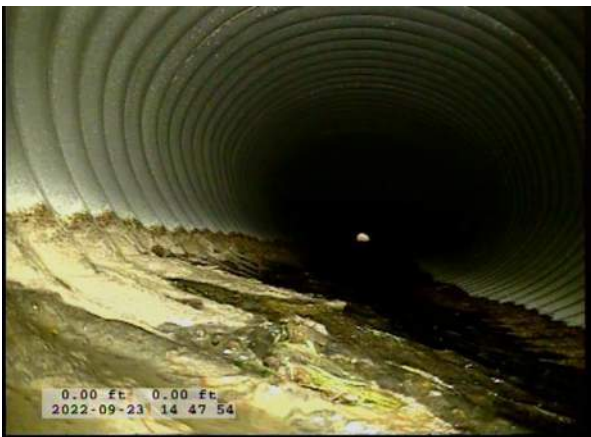
3, 00:00:23, 0.00ft
 Deposits Attached Encrustation, 5% of cross sectional area from 5 o'clock to 7 o'clock, within 8 inch, Start / RUST

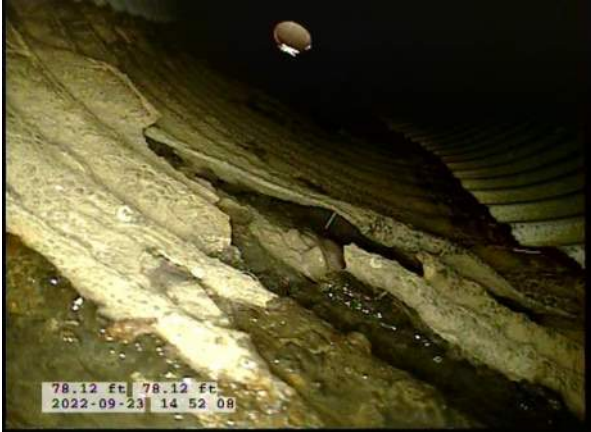
0.0 S01	DAE	Deposits Attached Encrustation, 5% of cross sectional area from 5 o'clock to 7 o'clock, within 8 inch, Start / RUST	00:00:23	3			
	0.0 S02	SMW	Surface Damage Missing Wall from 5 o'clock to 7 o'clock, within 8 inch, Start / BOTTOM OF PIPE HAS BEGUN TO RUST AWAY	00:00:29	4, 5

5, 00:00:29, 0.00ft
 Surface Damage Missing Wall from 5 o'clock to 7 o'clock, within 8 inch, Start / BOTTOM OF PIPE HAS BEGUN TO RUST AWAY

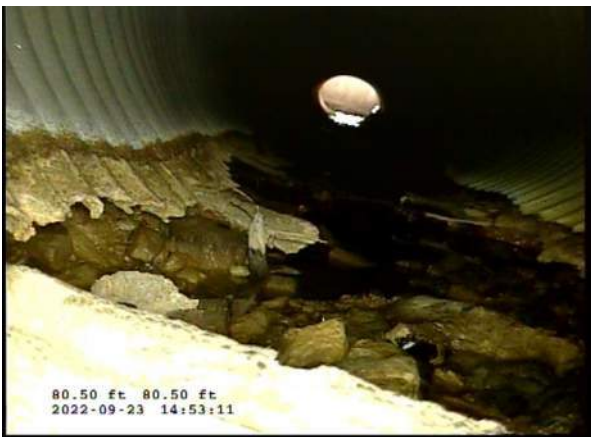
80.5	MGP	Miscellaneous General Photograph from 5 o'clock to 7 o'clock / BOTTOM OF PIPE COMPLETELY MISSING	00:04:39	6, 7			
	80.5 F01	DAE	Deposits Attached Encrustation, 5% of cross sectional area from 5 o'clock to 7 o'clock, within 8 inch, Finish / RUST	00:05:08	8	M2

7, 00:04:39, 80.50ft
 Miscellaneous General Photograph from 5 o'clock to 7 o'clock / BOTTOM OF PIPE COMPLETELY MISSING

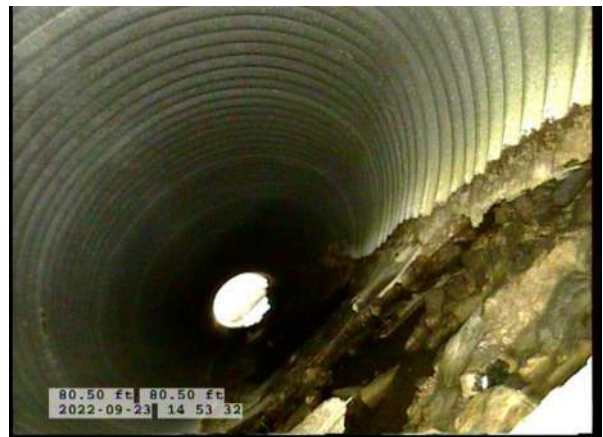
8, 00:05:08, 80.50ft
 Deposits Attached Encrustation, 5% of cross sectional area from 5 o'clock to 7 o'clock, within 8 inch, Finish / RUST

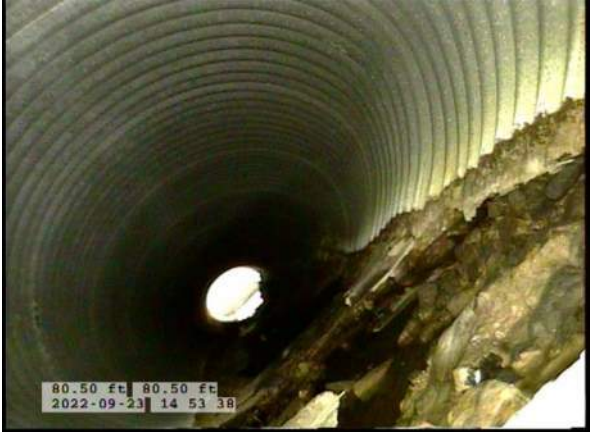
80.5 F02	SMW	Surface Damage Missing Wall from 5 o'clock to 7 o'clock, within 8 inch, Finish / BOTTOM OF PIPE HAS BEGUN TO RUST AWAY	00:05:10	9	S5		
	81.4	MSA	Miscellaneous Survey Abandoned / BOTTOM OF PIPE MISSING, OVERLAPPED WITH RUN FROM OPPOSITE DIRECTION	00:05:13	10, 11			
QSR	QMR	QOR	SPR	MPR	OPR	SPRI	MPRI	OPRI
5B00	2B00	5B2B	80.0	32.0	112.0	5.0	2.0	3.5

9, 00:05:10, 80.50ft
 Surface Damage Missing Wall from 5 o'clock to 7 o'clock, within 8 inch, Finish / BOTTOM OF PIPE HAS BEGUN TO RUST AWAY

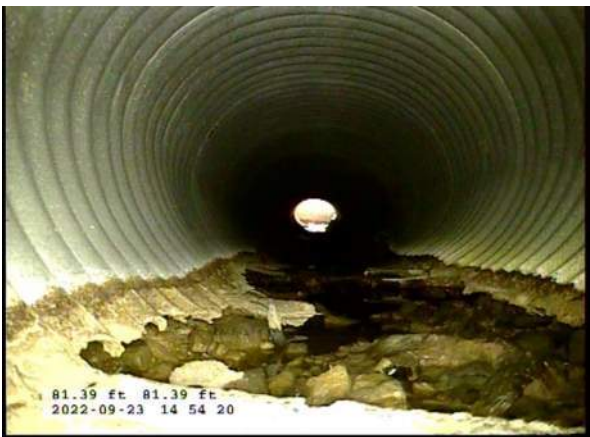
11, 00:05:13, 81.39ft
 Miscellaneous Survey Abandoned / BOTTOM OF PIPE MISSING, OVERLAPPED WITH RUN FROM OPPOSITE DIRECTION

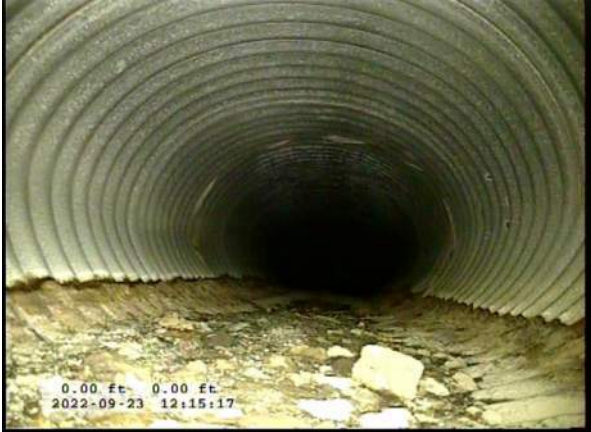
1, 00:00:11, 0.00ft
 Catch Basin / CB5

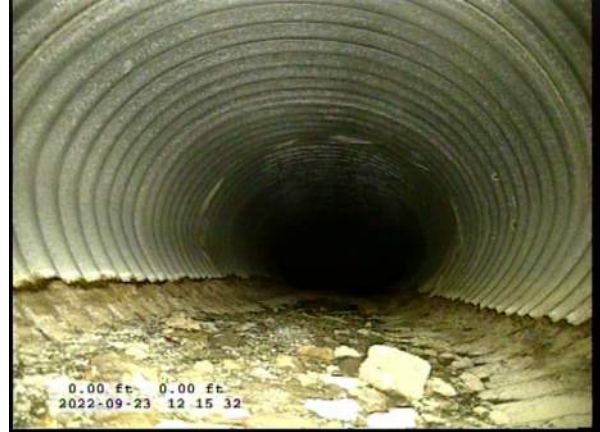
2, 00:00:13, 0.00ft
 Water Level, 0% of the vertical dimension

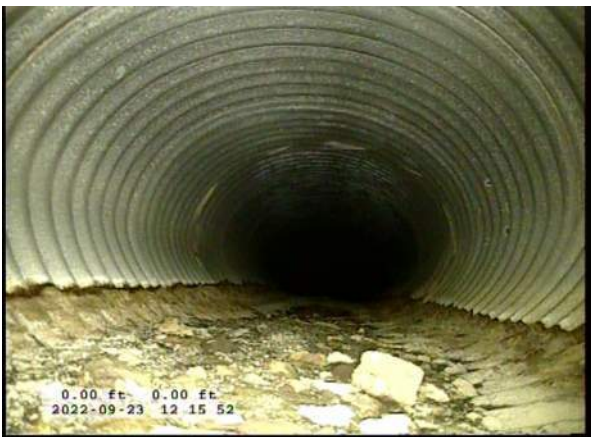
3, 00:00:16, 0.00ft
 Deposits Attached Encrustation, 5% of cross sectional area from 5 o'clock to 7 o'clock, within 8 inch, Start / RUST

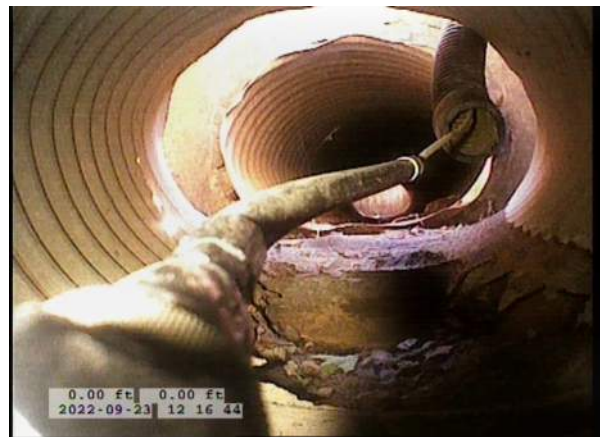
0.0	S01 DAE	Deposits Attached Encrustation, 5% of cross sectional area from 5 o'clock to 7 o'clock, within 8 inch, Start / RUST	00:00:16	3	
	0.0	MGO	Miscellaneous General Observation / STARTED RUN A COUPLE FEET INTO THE LINE DUE TO BOTTOM OF PIPE MISSING	00:00:25	4

4, 00:00:25, 0.00ft
 Miscellaneous General Observation / STARTED RUN A COUPLE FEET INTO THE LINE DUE TO BOTTOM OF PIPE MISSING

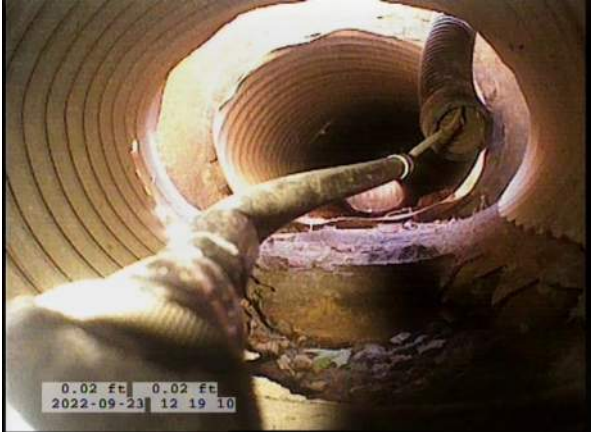
0.0	SMW	Surface Damage Missing Wall from 5 o'clock to 7 o'clock / CAMERA LOOKING BACKWARDS, BOTTOM OF PIPE MISSING AT START OF LINE	00:00:28	5	S5
	1.6	DSC	Deposits Settled Compacted, 5% of cross sectional area at 6 o'clock	00:00:55	6	M2

5, 00:00:28, 0.00ft
 Surface Damage Missing Wall from 5 o'clock to 7 o'clock /
 CAMERA LOOKING BACKWARDS, BOTTOM OF PIPE
 MISSING AT START OF LINE

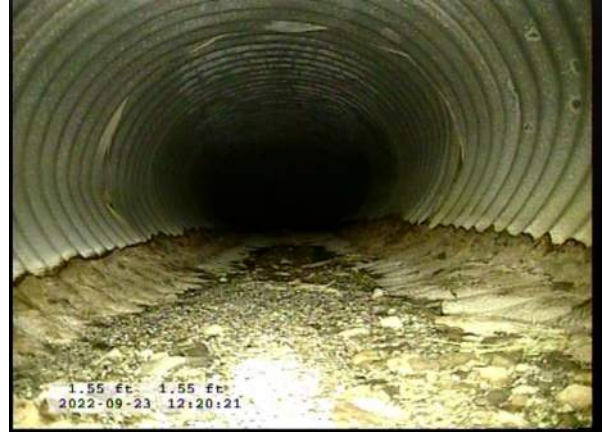
6, 00:00:55, 1.55ft
 Deposits Settled Compacted, 5% of cross sectional area at 6
 o'clock

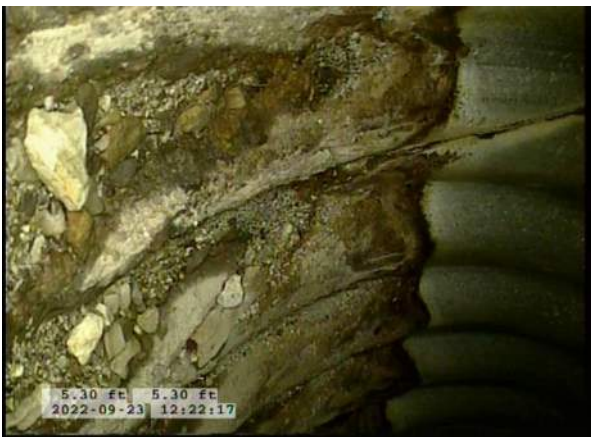
5.3	SMW	Surface Damage Missing Wall from 5 o'clock to 8 o'clock / PIPE HAS STARTED TO RUST AWAY	00:02:12	7, 8	S5
	10.6	S02 SMW	Surface Damage Missing Wall from 5 o'clock to 7 o'clock, within 8 inch, Start / BOTTOM OF PIPE HAS STARTED TO RUST AWAY	00:02:44	9, 10

7, 00:02:12, 5.30ft
 Surface Damage Missing Wall from 5 o'clock to 8 o'clock /
 PIPE HAS STARTED TO RUST AWAY

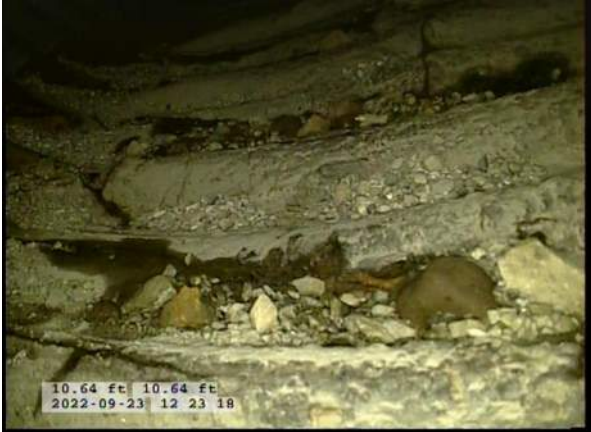
9, 00:02:44, 10.64ft
 Surface Damage Missing Wall from 5 o'clock to 7 o'clock,
 within 8 inch, Start / BOTTOM OF PIPE HAS STARTED TO
 RUST AWAY

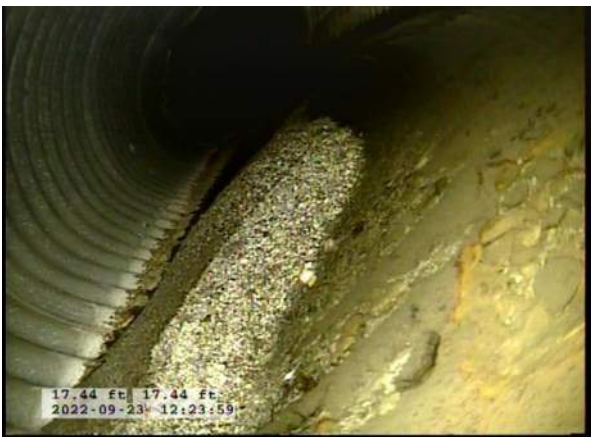
11, 00:03:18, 17.44ft
 Deposits Settled Fine, 5% of cross sectional area from 6
 o'clock to 7 o'clock

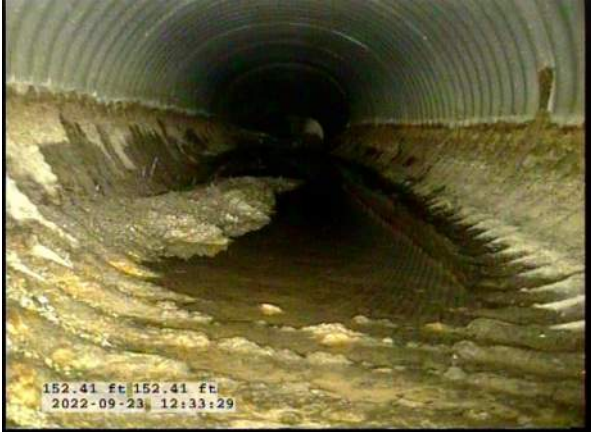
13, 00:12:38, 152.41ft
 Deposits Attached Encrustation, 5% of cross sectional area from 5 o'clock to 7 o'clock, within 8 inch, Finish / RUST

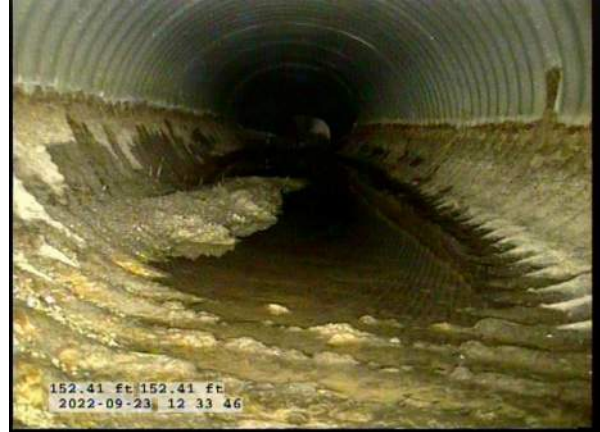
14, 00:12:41, 152.41ft
 Deposits Attached Encrustation, 5% of cross sectional area from 3 o'clock to 9 o'clock, within 8 inch, Start / RUST

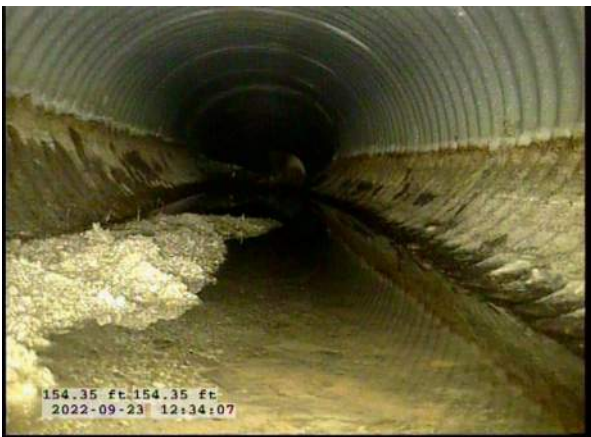
15, 00:12:53, 154.35ft
 Deposits Settled Fine, 5% of cross sectional area from 6 o'clock to 7 o'clock, within 8 inch, Start

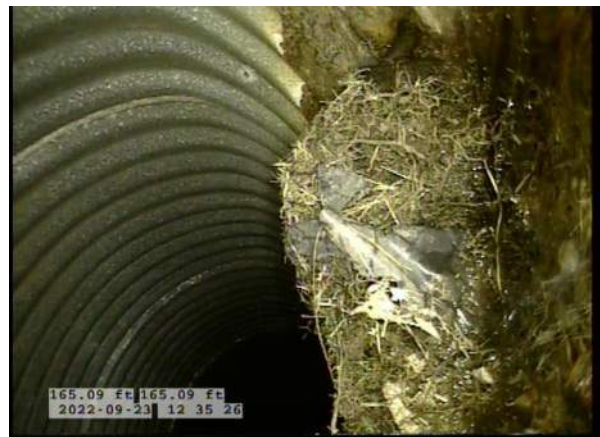
16, 00:13:57, 165.09ft
 Roots Medium Joint from 4 o'clock to 8 o'clock, 15% of cross sectional area, within 8 inch

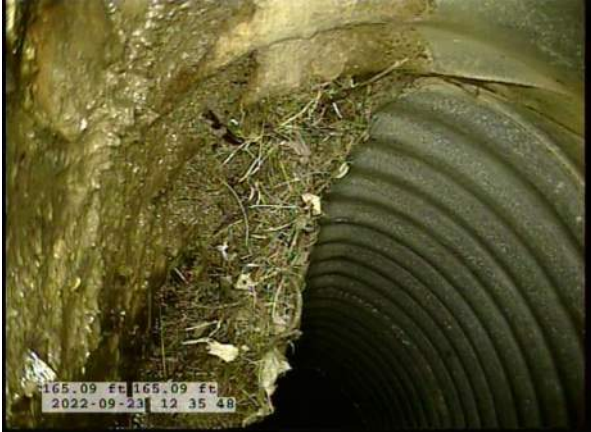
17, 00:13:57, 165.09ft
 Roots Medium Joint from 4 o'clock to 8 o'clock, 15% of cross sectional area, within 8 inch

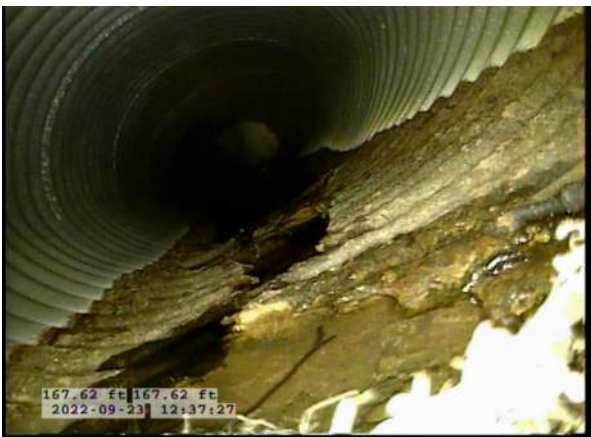
19, 00:15:41, 167.62ft
 Deposits Attached Encrustation, 5% of cross sectional area from 3 o'clock to 9 o'clock, within 8 inch, Finish / RUST

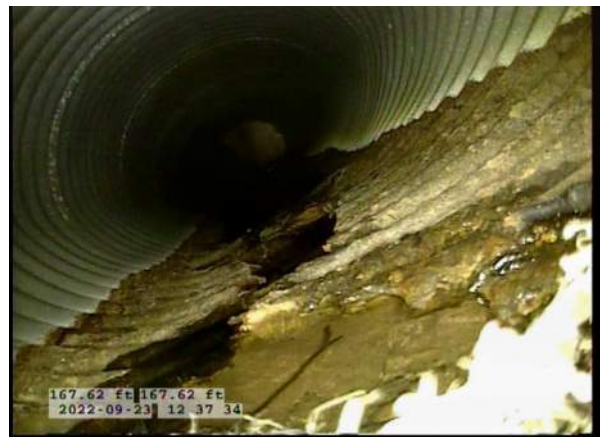
20, 00:15:45, 167.62ft
 Surface Damage Missing Wall from 5 o'clock to 7 o'clock, within 8 inch, Finish / BOTTOM OF PIPE HAS STARTED TO RUST AWAY

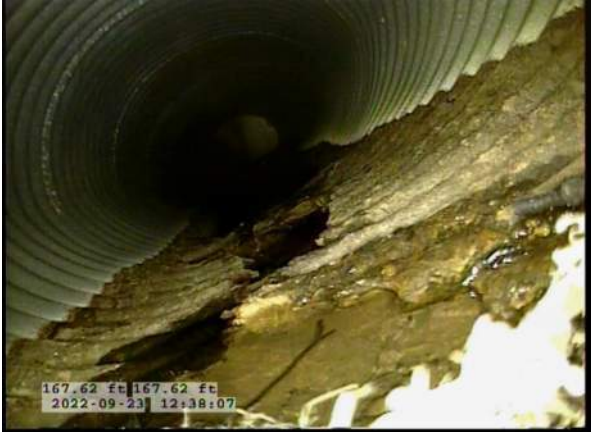
21, 00:15:49, 167.62ft
Miscellaneous Survey Abandoned / BOTTOM OF PIPE
MISSING, CRAWLER CANNOT PROCEED

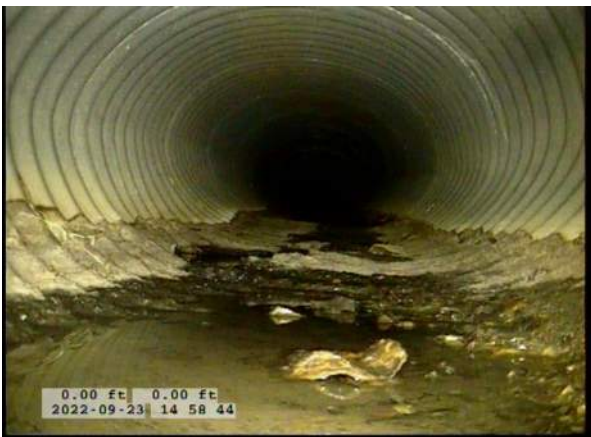
3, 00:00:16, 0.00ft
 Deposits Attached Encrustation, 5% of cross sectional area from 5 o'clock to 7 o'clock, within 8 inch, Start / RUST
