**West Manchester Township
Invitation to Bid
for the
Rainbow Circle Area Stormwater Repairs Project**

PROJECT: West Manchester Township – Rainbow Circle Area Stormwater Repairs Project

EXISTING CONDITIONS PLAN
 FOR
**RAINBOW CIRCLE
 STORMWATER**
 WEST MANCHESTER TOWNSHIP
 YORK COUNTY
 PENNSYLVANIA

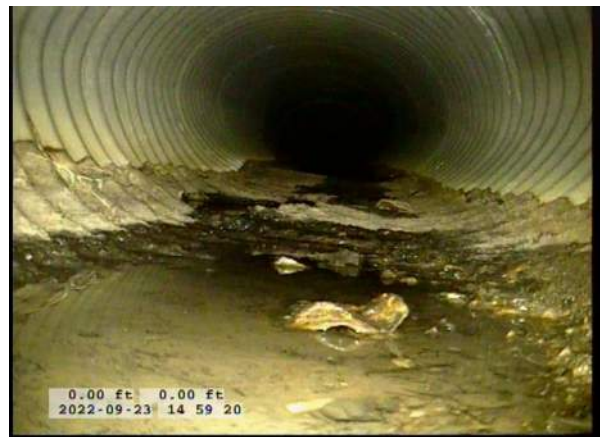
4, 00:00:26, 0.00ft
 Surface Damage Missing Wall from 5 o'clock to 7 o'clock, within 8 inch, Start / BOTTOM OF PIPE HAS BEGUN TO RUST AWAY

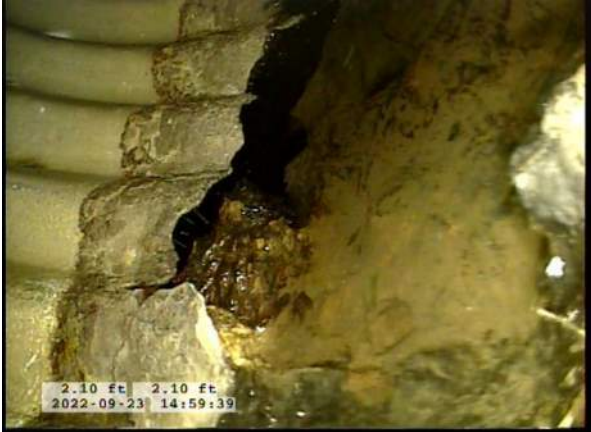
5, 00:00:26, 0.00ft
 Surface Damage Missing Wall from 5 o'clock to 7 o'clock,
 within 8 inch, Start / BOTTOM OF PIPE HAS BEGUN TO
 RUST AWAY

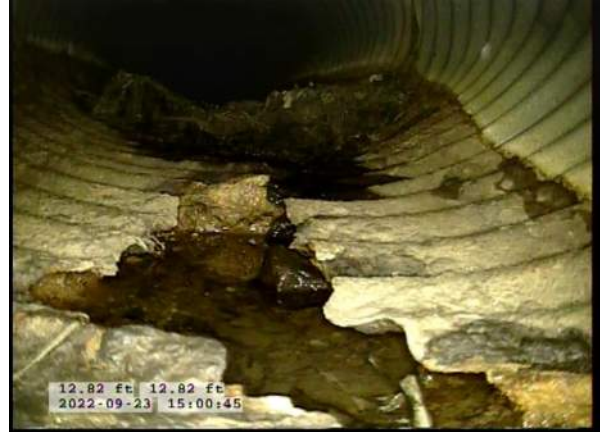
6, 00:01:43, 12.82ft
 Deposits Attached Encrustation, 5% of cross sectional area
 from 5 o'clock to 7 o'clock, within 8 inch, Finish / RUST

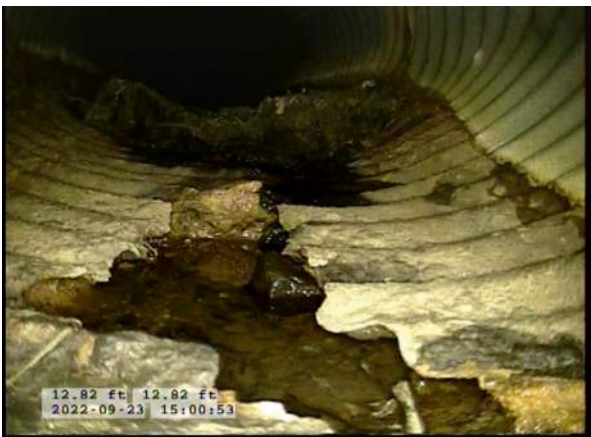
7, 00:01:47, 12.82ft
 Surface Damage Missing Wall from 5 o'clock to 7 o'clock,
 within 8 inch, Finish / BOTTOM OF PIPE HAS BEGUN TO
 RUST AWAY

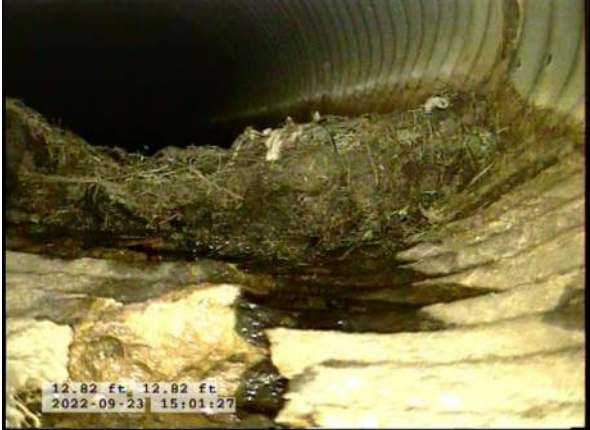
9, 00:01:51, 12.82ft
 Miscellaneous General Observation / BITTOM OF PIPE COMPLETELY MISSING

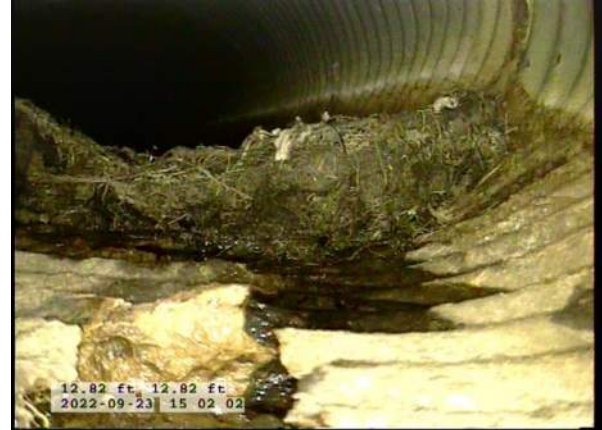
10, 00:02:05, 12.82ft
 Miscellaneous Survey Abandoned / BOTTOM OF PIPE MISSING, OVERLAPPED WITH RUN FROM OPPOSITE DIRECTION

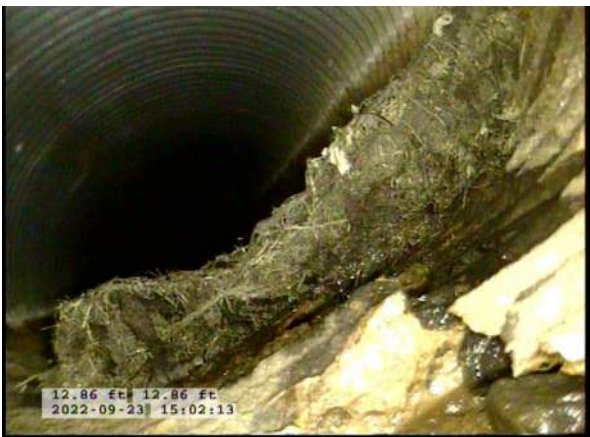
11, 00:02:05, 12.82ft
 Miscellaneous Survey Abandoned / BOTTOM OF PIPE MISSING, OVERLAPPED WITH RUN FROM OPPOSITE DIRECTION

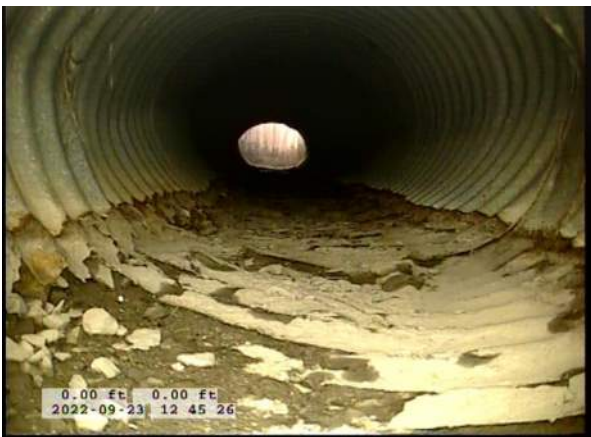
3, 00:00:21, 0.00ft
 Deposits Attached Encrustation, 5% of cross sectional area from 5 o'clock to 7 o'clock, within 8 inch, Start / RUST

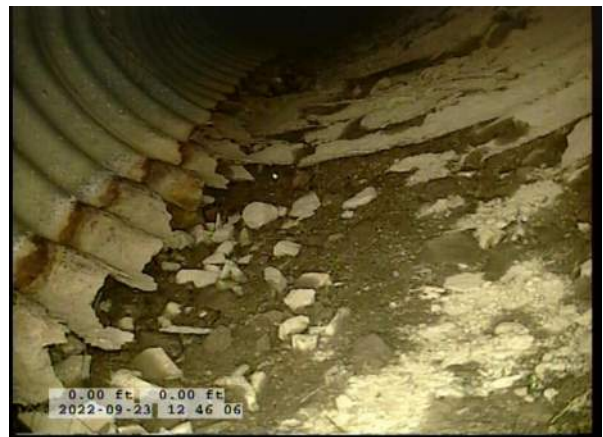
4, 00:00:31, 0.00ft
 Surface Damage Missing Wall from 5 o'clock to 7 o'clock, within 8 inch, Start / BOTTOM OF PIPE HAS BEGUN RUSTING AWAY

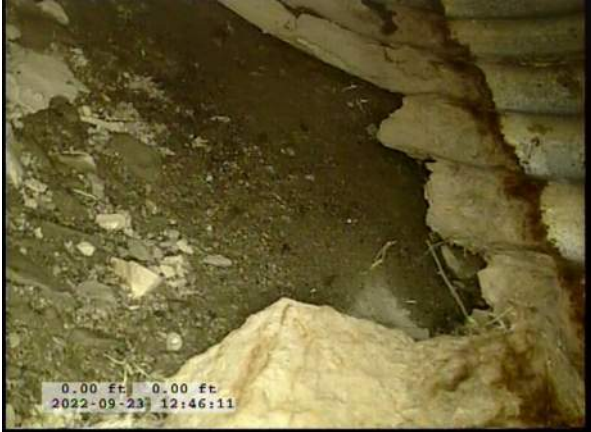
5, 00:00:31, 0.00ft
 Surface Damage Missing Wall from 5 o'clock to 7 o'clock,
 within 8 inch, Start / BOTTOM OF PIPE HAS BEGUN
 RUSTING AWAY

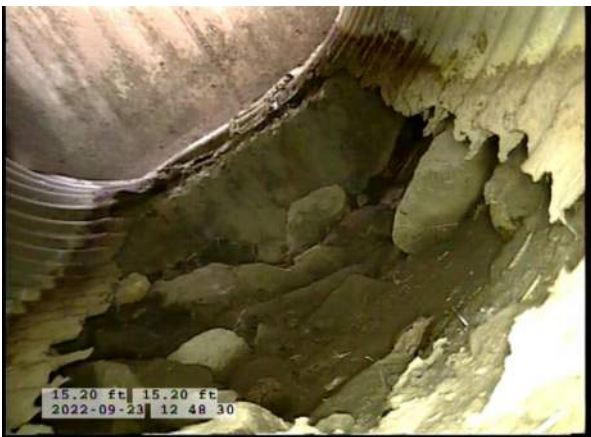
7, 00:01:56, 15.20ft
 Miscellaneous General Photograph from 5 o'clock to 7 o'clock /
 BOIIOM OF PIPE COMPLETELY MISSING JUST BEFORE
 CB4

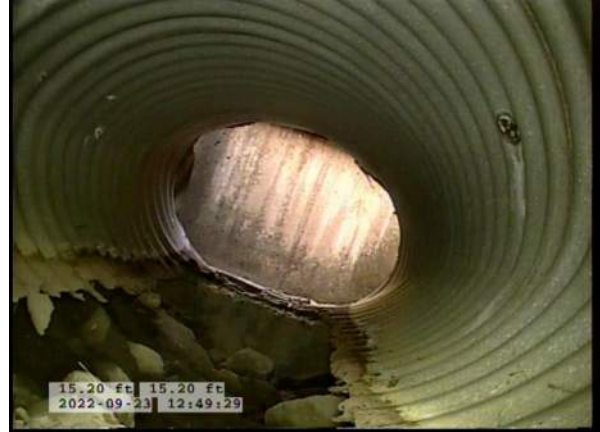
10, 00:02:27, 15.20ft
 Surface Damage Missing Wall from 5 o'clock to 7 o'clock, within 8 inch, Finish / BOTTOM OF PIPE HAS BEGUN RUSTING AWAY

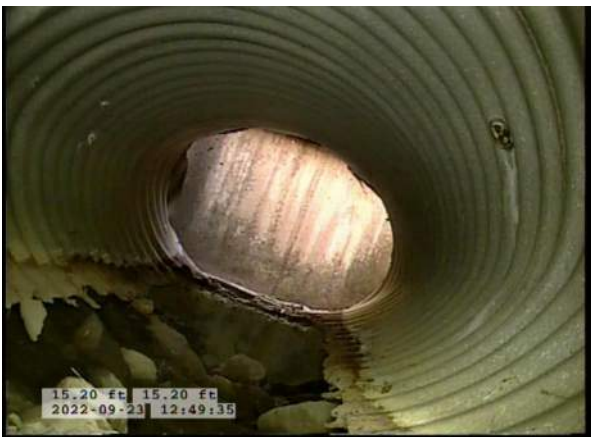
11, 00:02:30, 15.20ft
 Deposits Attached Encrustation, 5% of cross sectional area from 5 o'clock to 7 o'clock, within 8 inch, Finish / RUST

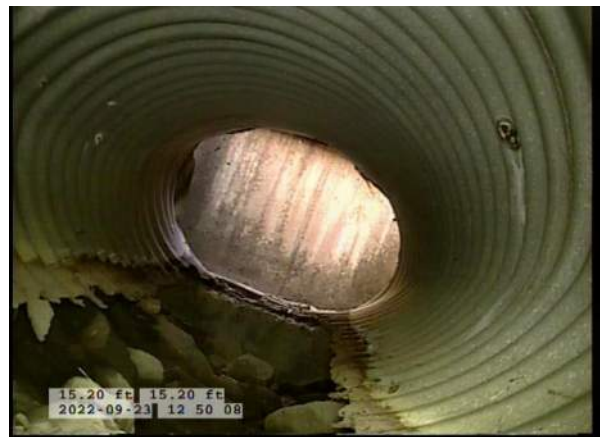
12, 00:02:36, 15.20ft
 Miscellaneous Survey Abandoned / BOTTOM OF PIPE MISSING, CRAWLER CANNOT PROCEED

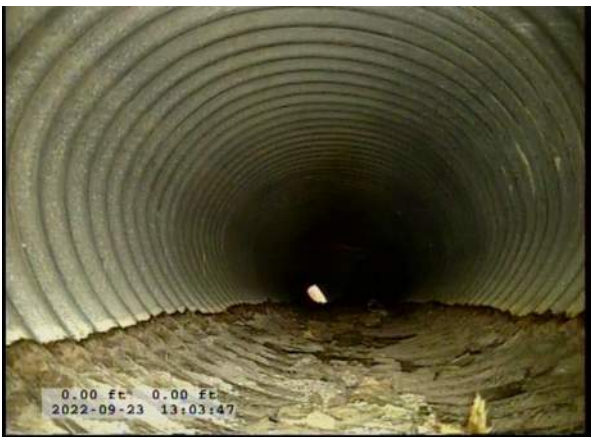
3, 00:00:22, 0.00ft
 Deposits Attached Encrustation, 5% of cross sectional area from 5 o'clock to 7 o'clock, within 8 inch, Start / RUST

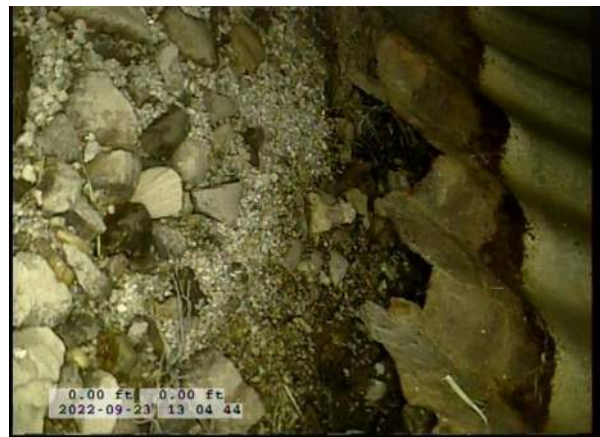
4, 00:00:37, 0.00ft
 Surface Damage Missing Wall from 5 o'clock to 7 o'clock, within 8 inch, Start / BOTTOM OF PIPE HAS BEGUN RUSTING AWAY

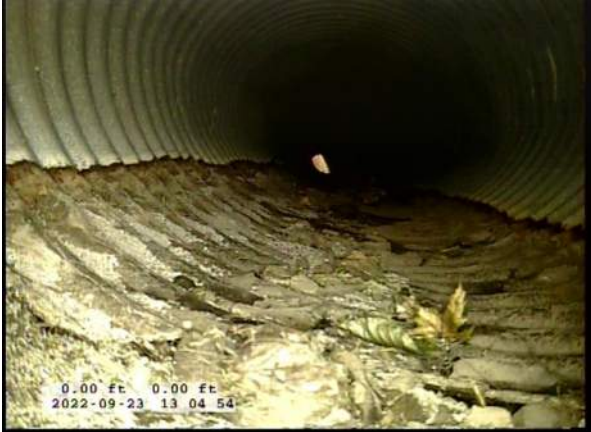
5, 00:00:37, 0.00ft
 Surface Damage Missing Wall from 5 o'clock to 7 o'clock, within 8 inch, Start / BOTTOM OF PIPE HAS BEGUN RUSTING AWAY

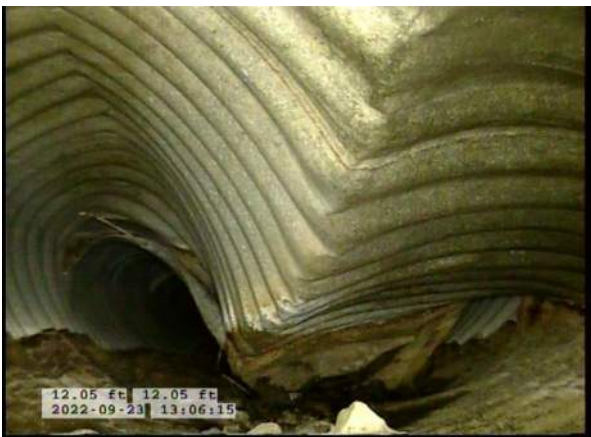
12.1	X	Collapse, 80% of cross sectional area	00:01:40	6, 7	S5		
	14.1 F02	SMW	Surface Damage Missing Wall from 5 o'clock to 7 o'clock, within 8 inch, Finish / BOTTOM OF PIPE HAS BEGUN RUSTING AWAY	00:03:05	8	S5

7, 00:01:40, 12.05ft
 Collapse, 80% of cross sectional area

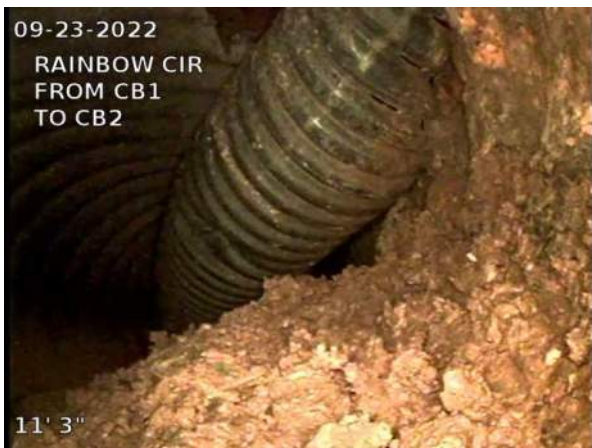
7, 00:00:56, 11.25ft
 Miscellaneous General Observation / 10 INCH CPP PIPE FROM CB2 VISIBLE

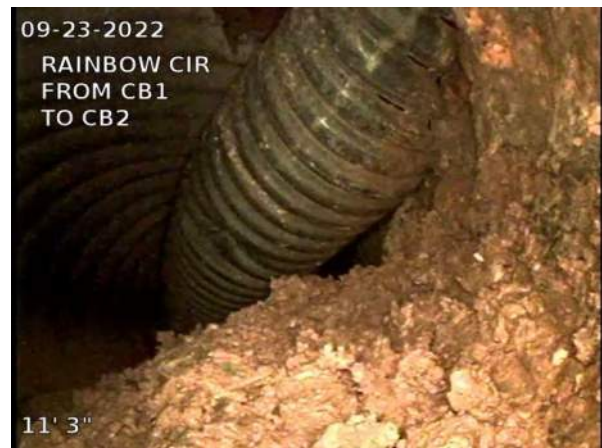
8, 00:00:56, 11.25ft
 Miscellaneous General Observation / 24 INCH CMP BEING USED AS A CONDUIT FOR THE 10 INCH CPP FROM CB2

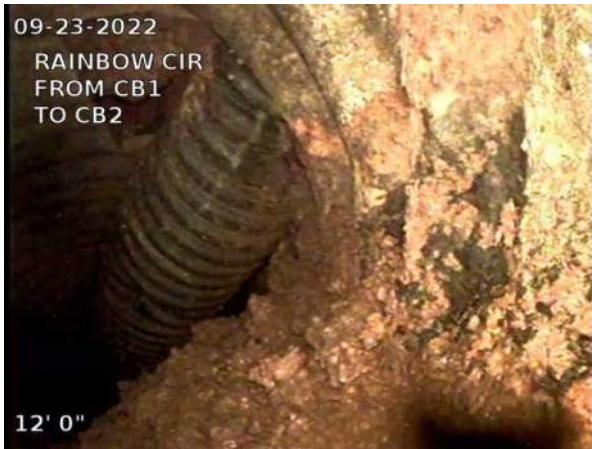
9, 00:00:56, 11.25ft
 Miscellaneous General Observation / 24 INCH CMP BEING USED AS A CONDUIT FOR THE 10 INCH CPP FROM CB2

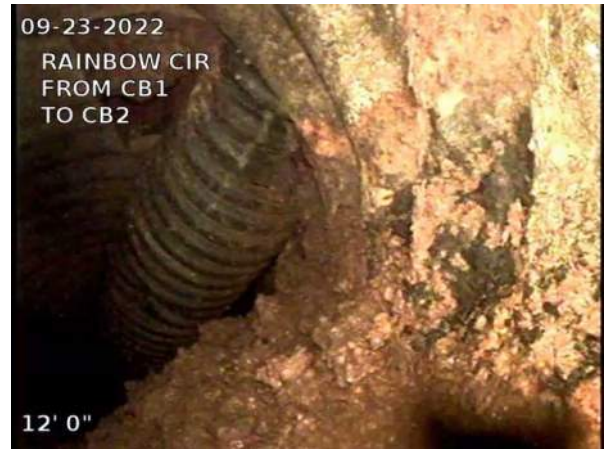
10, 00:01:24, 12.00ft
 Obstruction External Pipe or Cable, 40% of cross sectional area from 12 o'clock to 12 o'clock / 10 INCH CPP FROM CB2

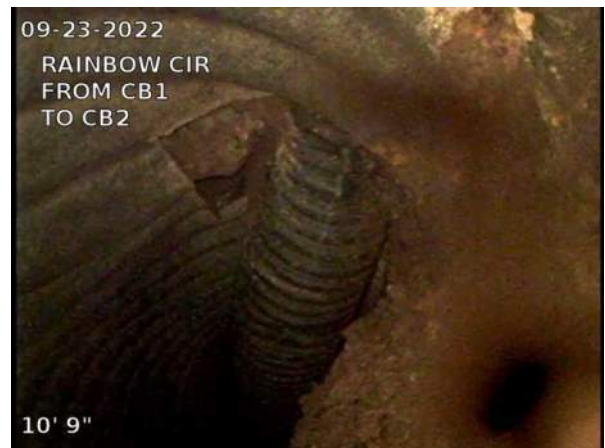
12, 00:01:24, 12.00ft
 Obstruction Intruding Through Wall, 40% of cross sectional area from 12 o'clock to 12 o'clock / 10 INCH CPP EXITING LINE THROUGH THE WALL OF THE 24 INCH CMP

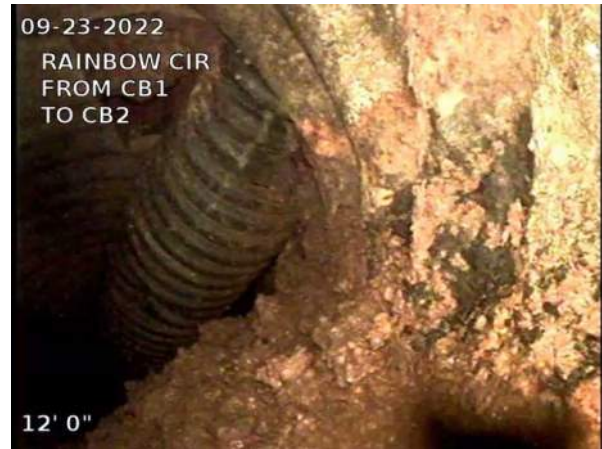
12.0	F02 DSGV	Deposits Settled Gravel, 10% of cross sectional area from 5 o'clock to 7 o'clock, within 8 inch, Finish	00:01:24	13	M2
	12.0	F01 DAE	Deposits Attached Encrustation, 5% of cross sectional area from 5 o'clock to 7 o'clock, within 8 inch, Finish / RUST	00:01:24	14	M2

14, 00:01:24, 12.01ft
 Deposits Attached Encrustation, 5% of cross sectional area from 5 o'clock to 7 o'clock, within 8 inch, Finish / RUST
