#### West Manchester Township Invitation to Bid for the

#### Rainbow Circle Area Stormwater Phase 3 Repairs Project

EXISTING CONDITIONS PLAN
FOR
RAINBOW CIRCLE
STORMWATER PHASE 3
WEST MANCHESTER TOWNSHIP

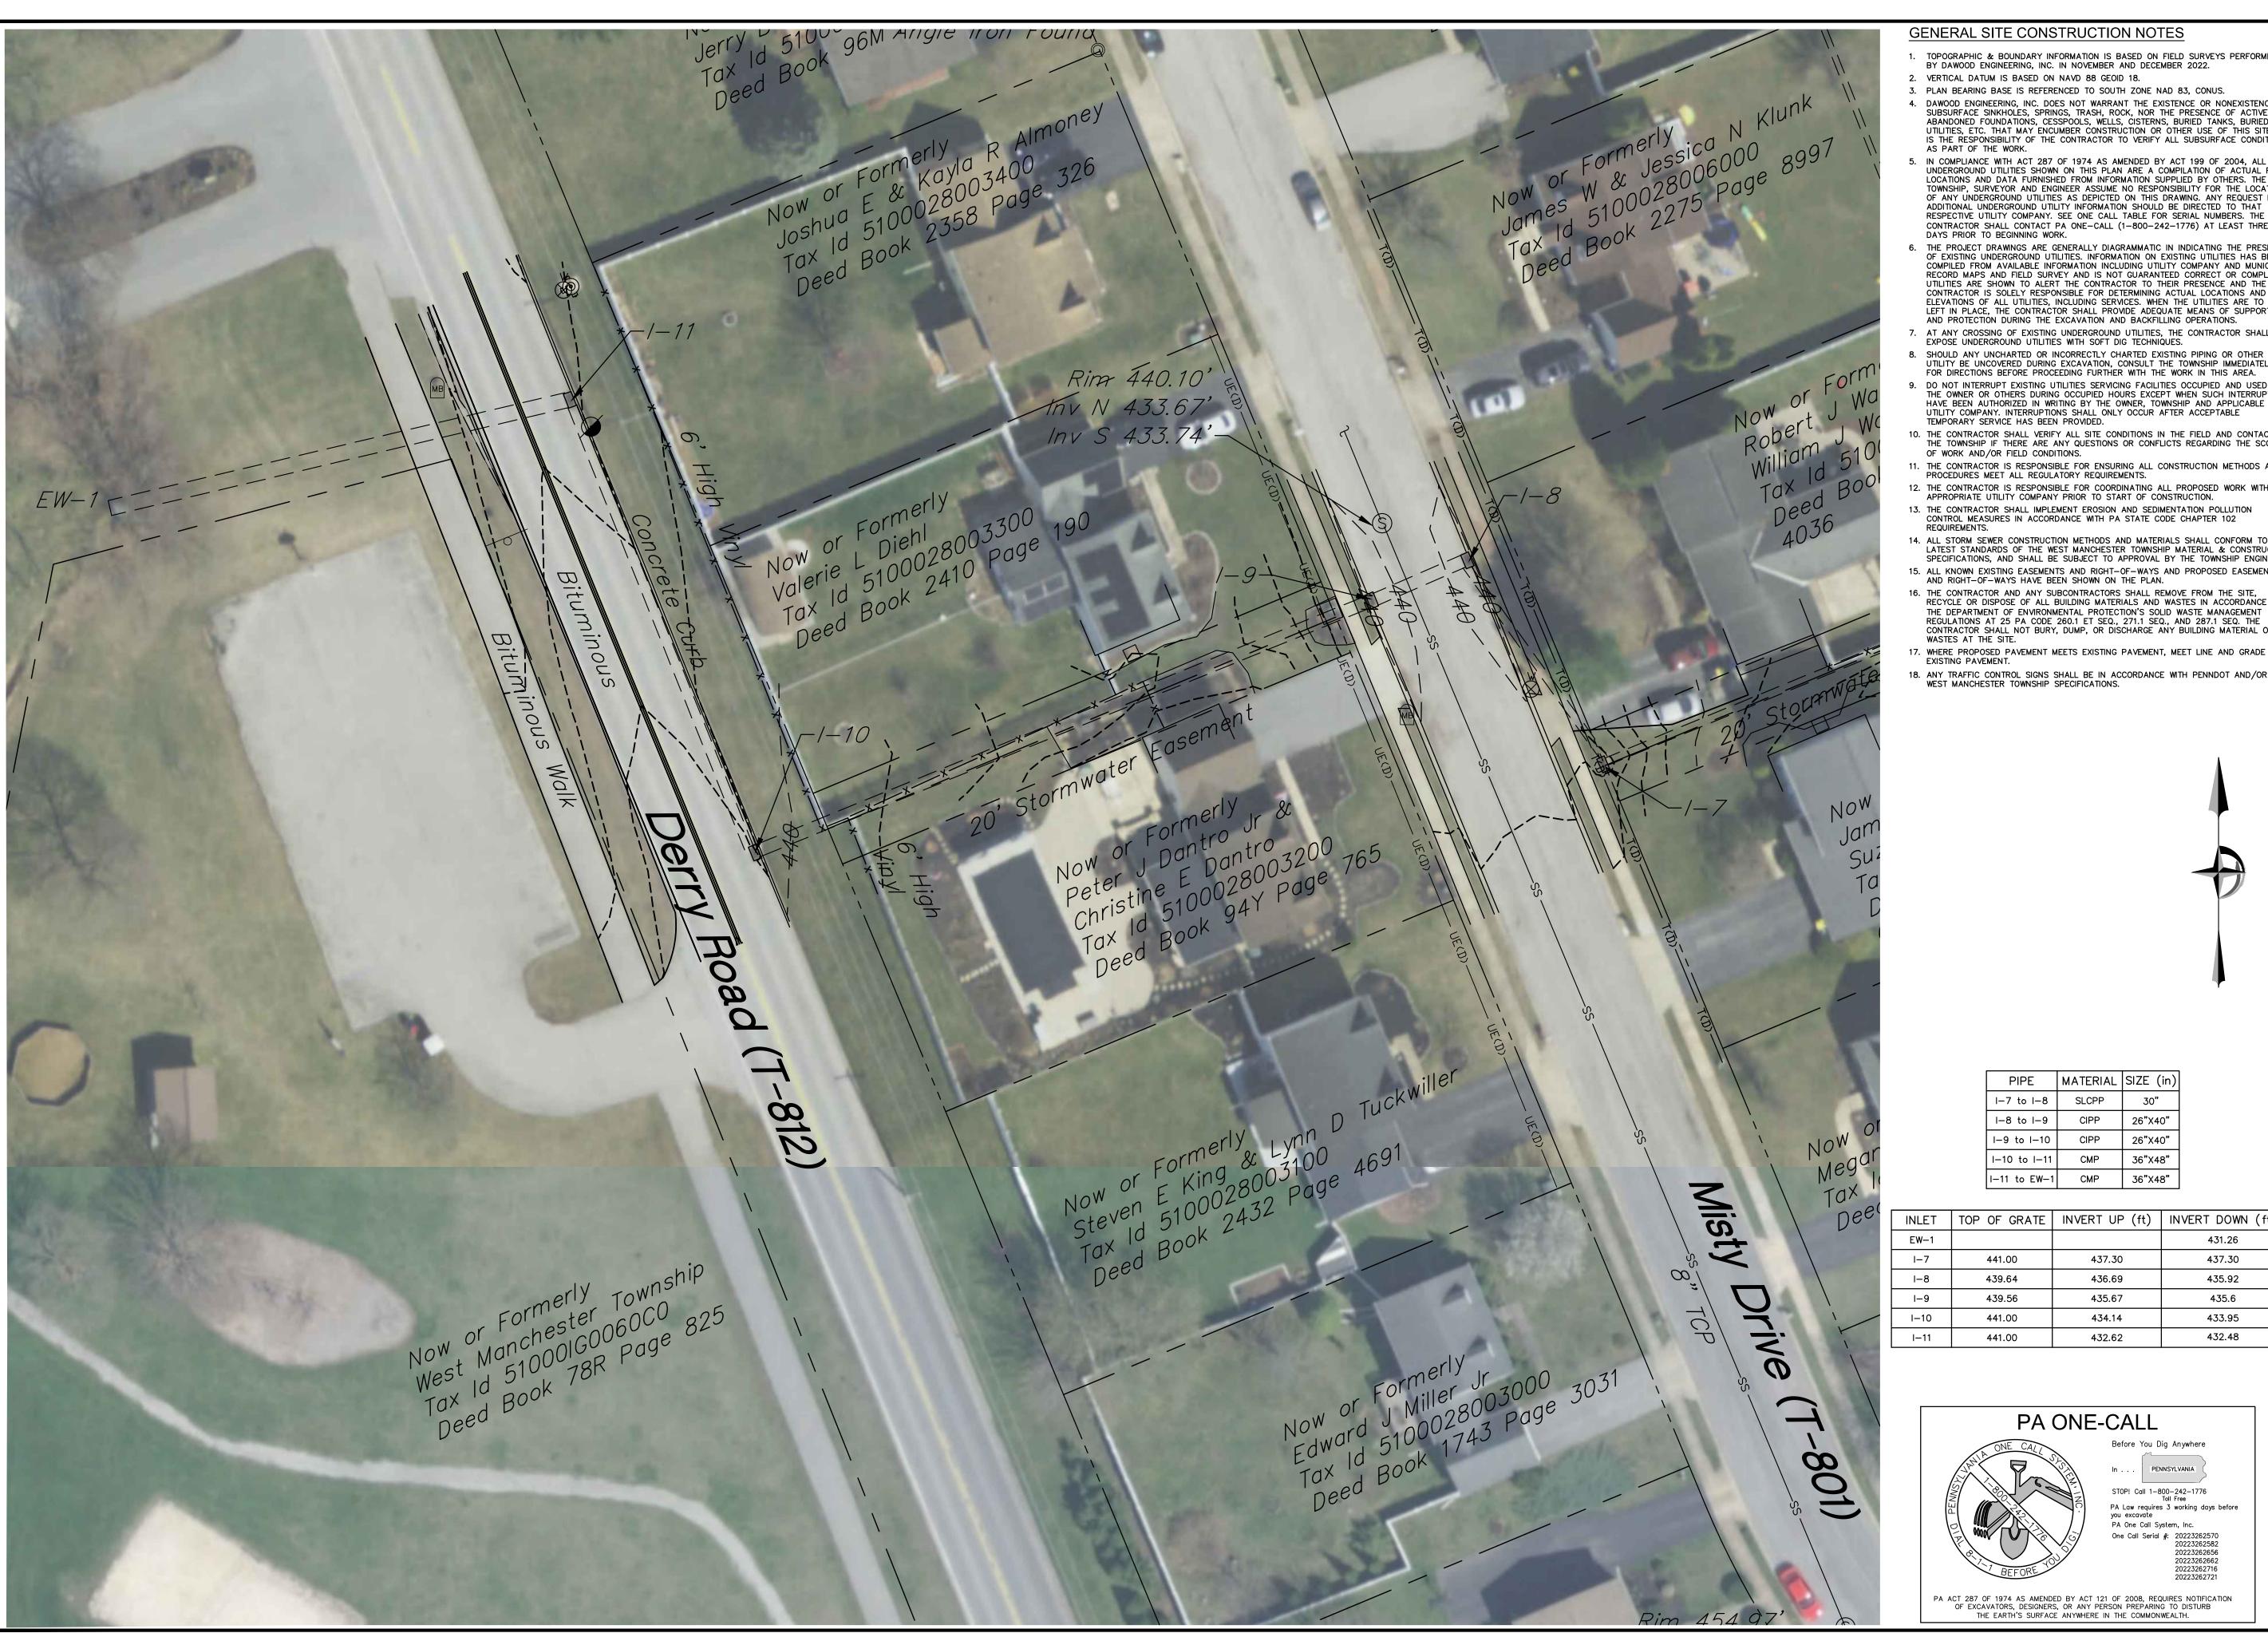
DRAWING TITLE EXISTING CONDITIONS PLAN

The existing conditions drawing depicts the area in which the work will be conducted. The work of the Rainbow Circle project is considered stormwater repair work and no plans depicting the scope will be provide. Approximately, 226 linear feet (LF) of pipe and two (2) inlet catch basins will be replaced as part of the work. The selected bidder will also install an end wall, be responsible for all erosion and sediment control, and any needed traffic control.

The work will include replacing the existing pipes with approximately 492 LF of 24-inch high density polyethylene (HDPE) smooth-lined corrugated plastic pipe (SLCPP) between inlet I-10 to I-11 and I-11 to an outfall. The existing pipe, which is 36-inch by 48-inch corrugate metal pipe (CMP) will be replaced by two (2) side-by-side 24-inch HDPE SLCP. All pipe replacements will be completed by open cut replacement. The Township will provide all the HDPE pipe, all the inlets, and the endwall. The contractor will be responsible for providing all other material relating to the construction of the project.

Inlet I-11 shall be replaced with a catch basin having pipe inverts at 432.62 feet above sea level (FASL) entering and 432.62 feet FASL exiting. The existing inlet I-11 pipe inverts are at 432.62 and 432.48 FASL. Inlet I-10 shall be replaced with a catch basin having pipe inverts at 434.14 feet FASL entering and 433.95 FASL exiting. The existing inlet I-10 pipe inverts are at 434.14 and 433.95 FASL. The top of all inlets shall be set at the elevation of the existing inlets, and the immediate area shall be graded toward the inlet. There is fencing around one of the properties in between I-10 and I-11. If this or any other existing features are disturbed during the work, such shall be replaced by the contract at no additional cost to the Township.
